Routes 7/15 Interchange Norwalk, Connecticut State Project No. 102-358

Environmental Assessment, Draft Section 4(F) Evaluation and Environmental Impact Evaluation

# PUBLIC REPORT PHASE I AND II CULTURAL RESOURCE SURVEYS ROUTE 7/ROUTE 15 INTERCHANGE PROJECT STATE PROJECT NO. 102-358 NORWALK, CONNECTICUT

December 13, 2018 Updated August 24, 2020

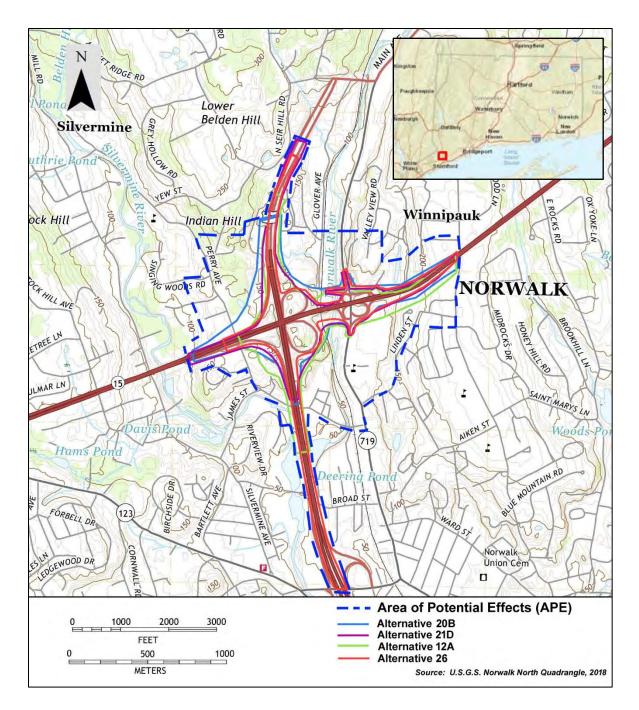
Figure 2: Map of Area of Potential Effects (APE). The APE includes the Project Site, which is the extent of construction activities/direct effects associated with all four alternatives, as well as the maximum extent of potential indirect effects such as visual, noise, vibration, air quality, and traffic effects.

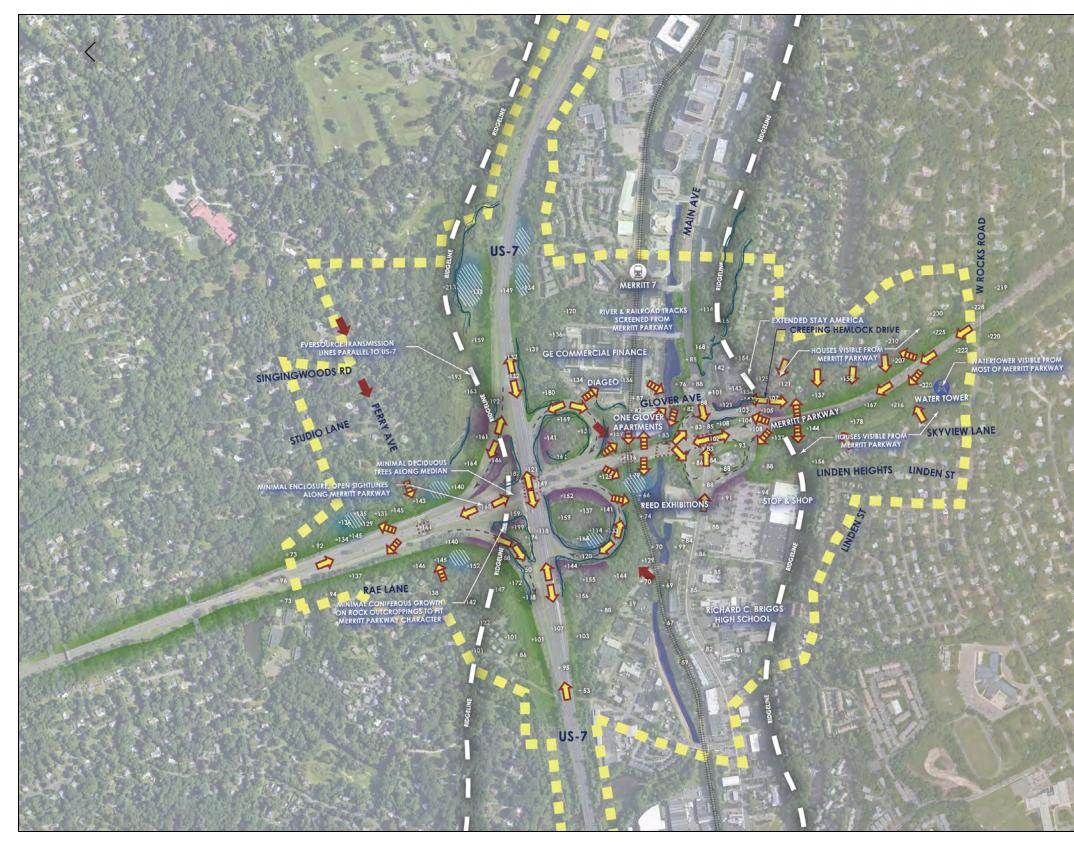
Figure 3:Map of Area of Potential Effects (APE) with Visual Impact Analysis.

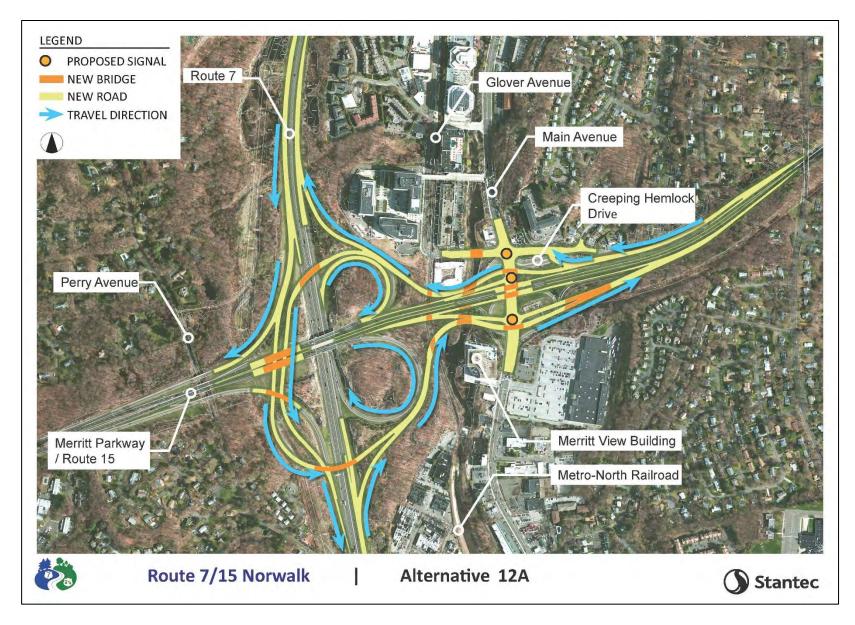
Figure 4: Aerial depiction of Alternative 12A.

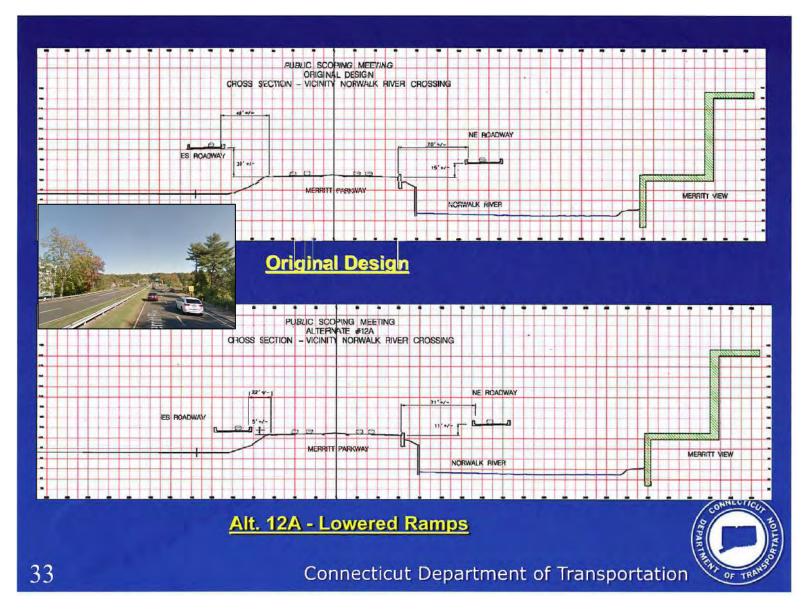
Figure 5: Project conceptual plans depicting elevation of Alternative 12A. Inset photo: Merritt Parkway, camera facing east toward the Norwalk River overpass (Google Street View, October 2017).

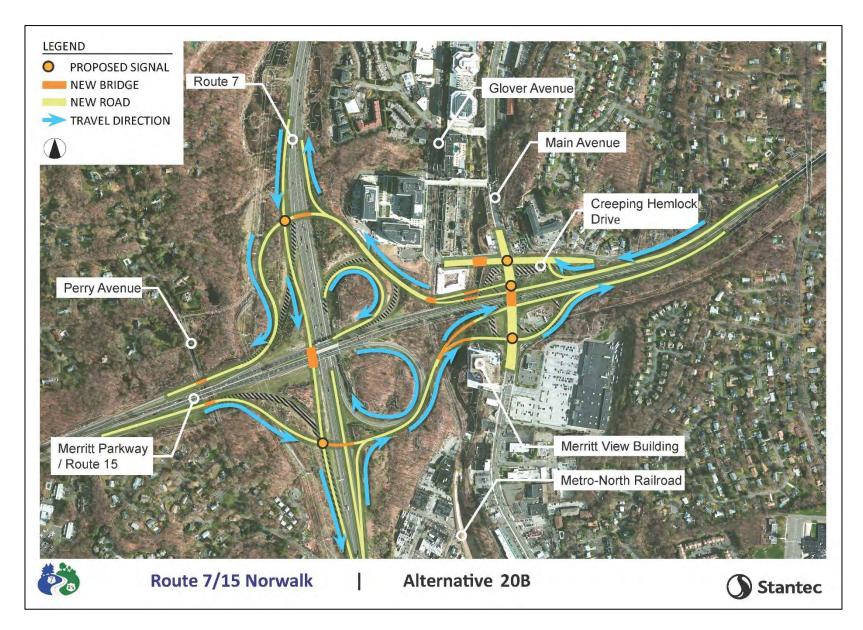
Figure 6: Aerial depiction of Alternative 20B.

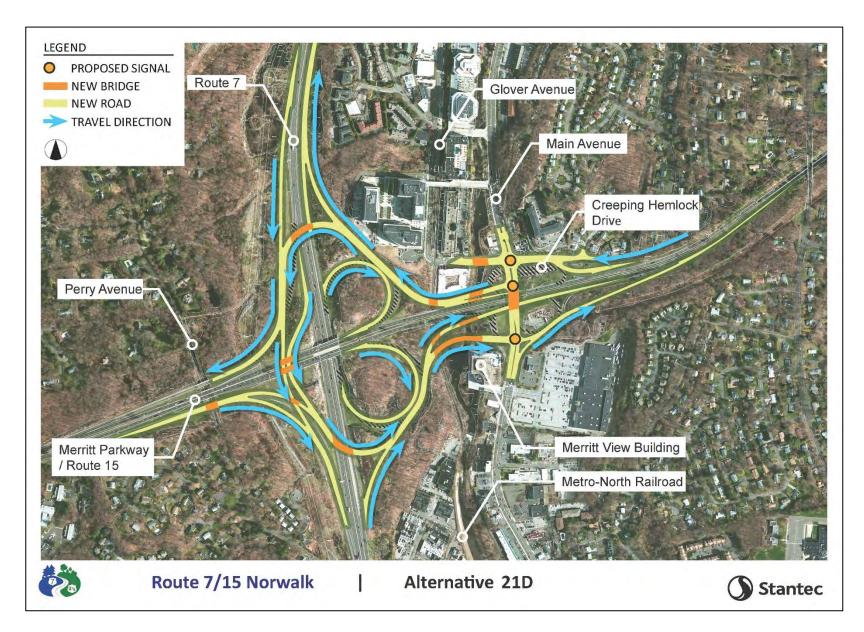
Figure 7: Aerial depiction of Alternative 21D.

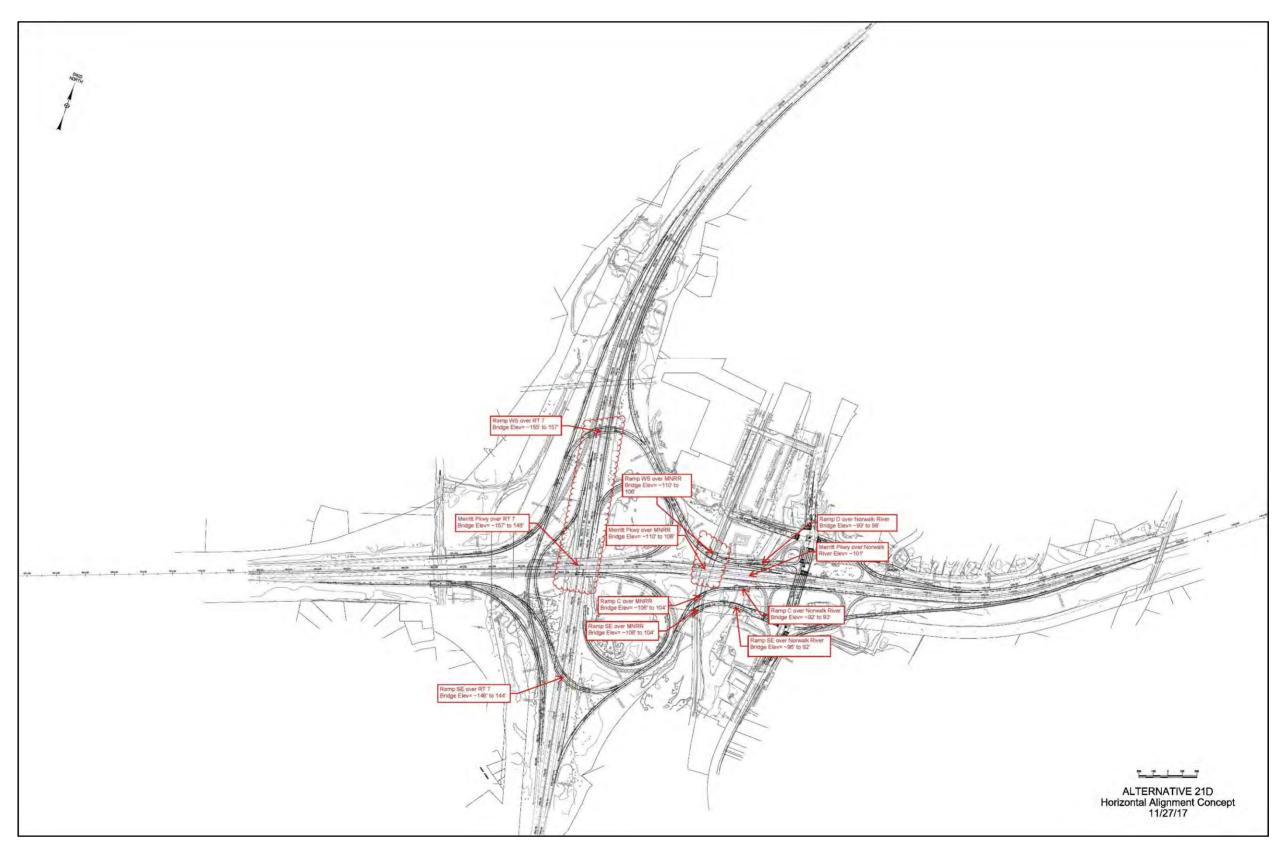
Figure 8: Project conceptual plans depicting elevation of Alternative 21D.

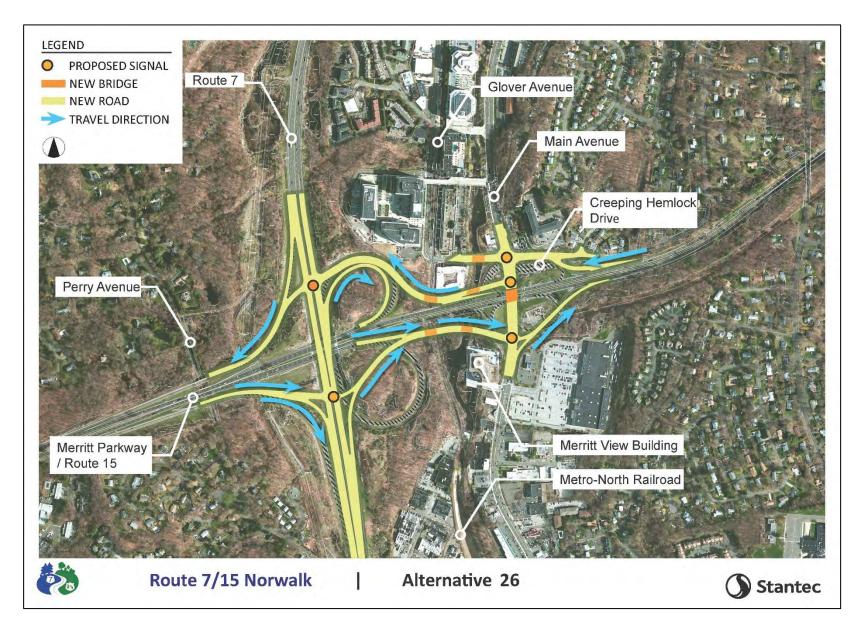
Figure 9: Aerial depiction of Alternative 26.

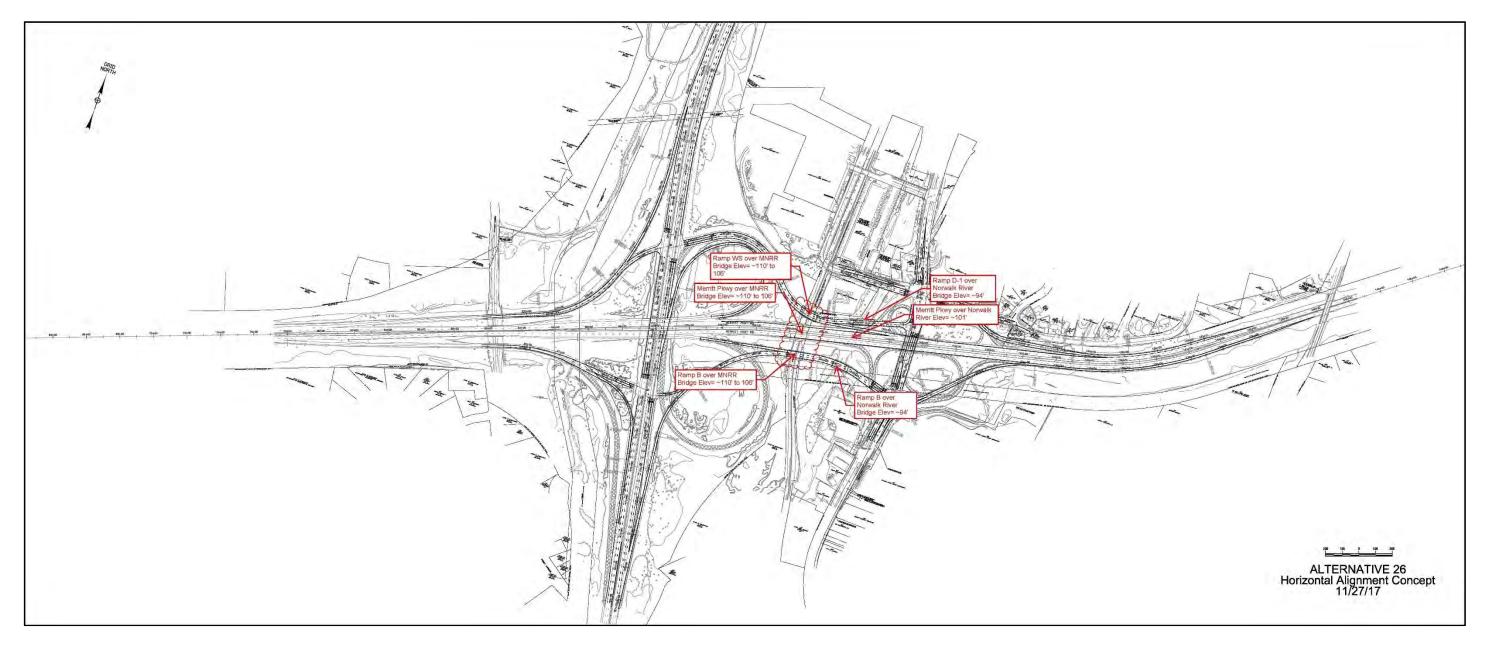
Figure 10: Project conceptual plans depicting elevation of Alternative 26.

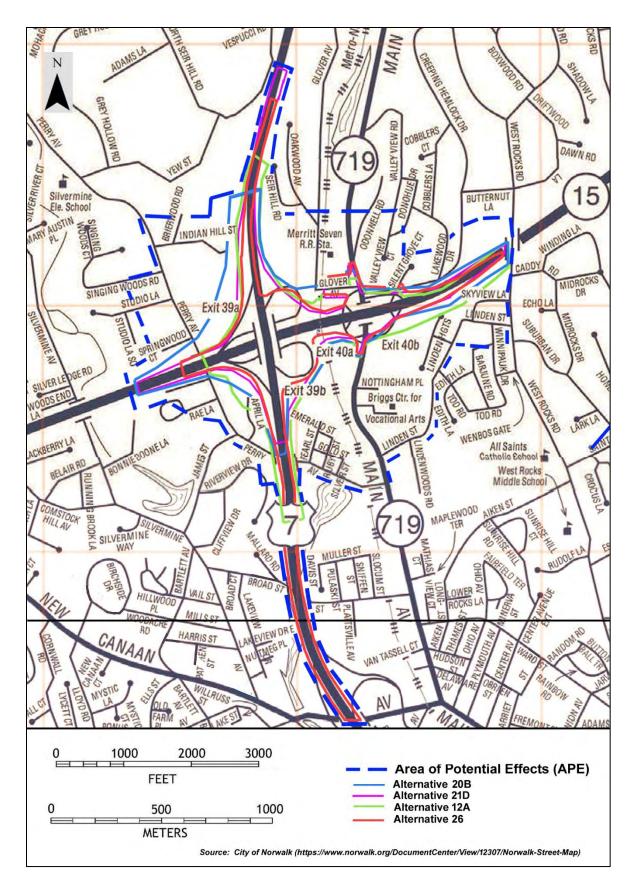
Figure 11: Map of the APE, shown with Norwalk municipal map background.

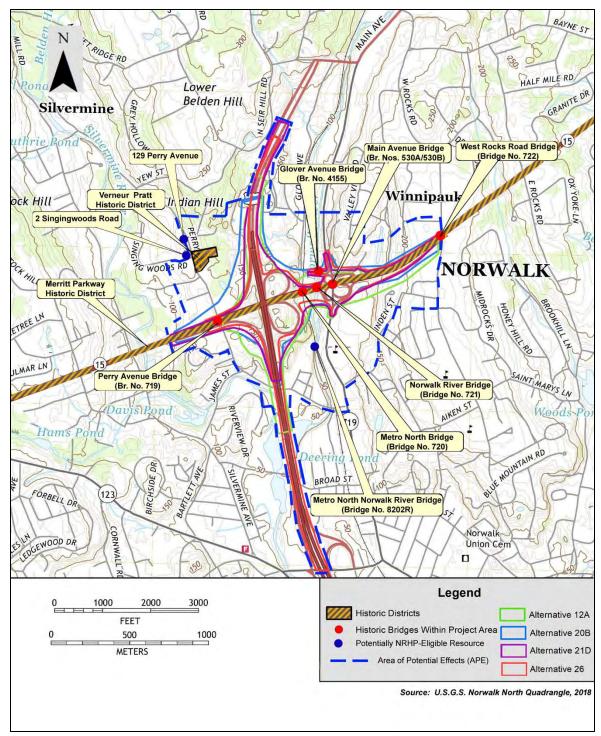
Figure 12: APE and historic resources, shown on USGS Norwalk North Quadrangle.

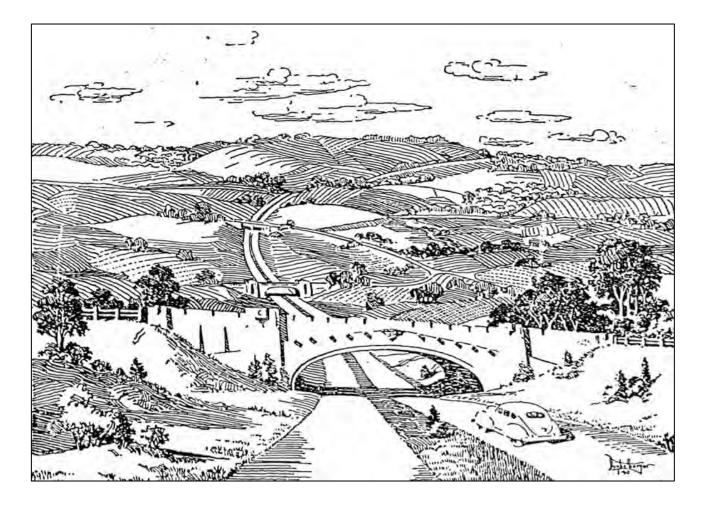
Image 9: George Dunkelberger drawing, 1940, illustrating the concept of the Parkway's aesthetically detailed bridges being set within vistas of open countryside, from Lynn and Wigren (1991).

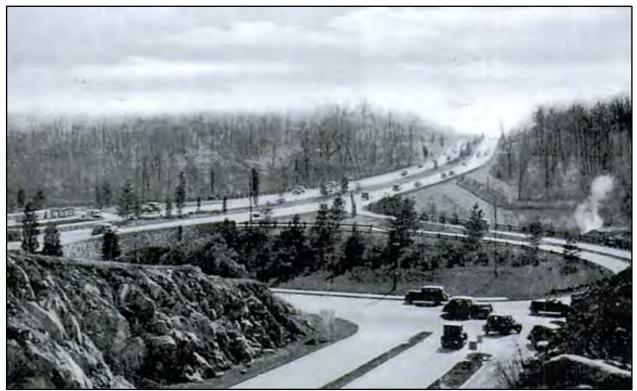
Image 10: Undated (ca. 1940?) photograph of the Main Avenue cloverleaf, with the Main Avenue Bridge on the left. The Winnipauk School was located on the bluff to the left, from Bepler (1999).

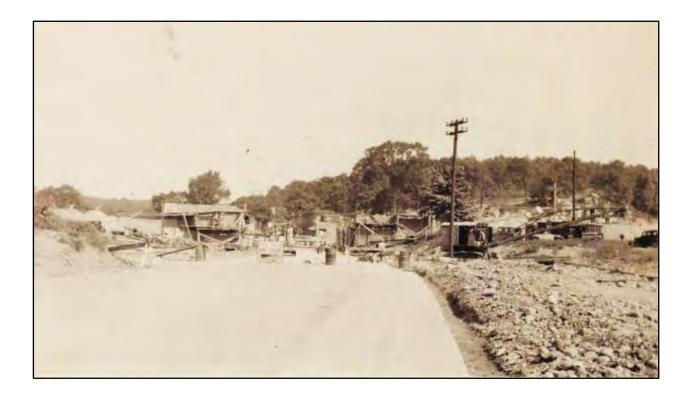
Image 11:1937 photograph of the Main Avenue Bridge construction (Connecticut State<br/>Library, Merritt Parkway Construction Collection).

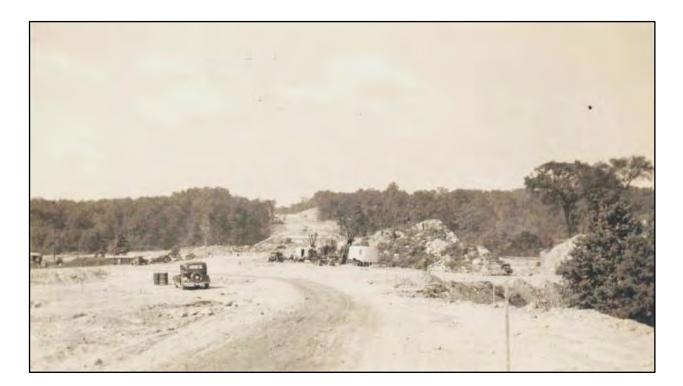
Image 12: 1937 photograph of the Merritt Parkway, camera facing west toward Main Avenue (Connecticut State Library, Merritt Parkway Construction Collection).

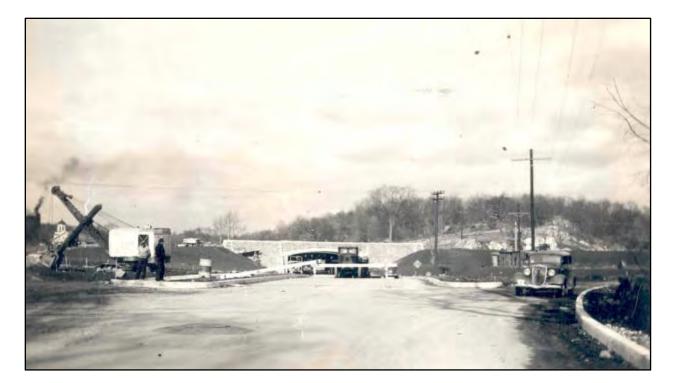
Image 13: 1937 photograph of the construction of the Merritt Parkway bridge over Main Avenue (Connecticut State Library, Merritt Parkway Construction Collection).

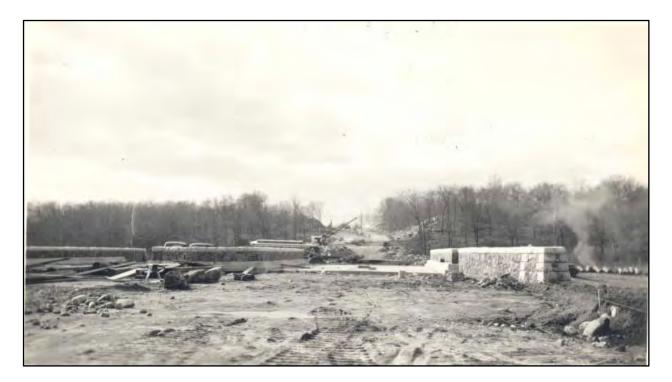
Image 14: 1937 photograph of the Merritt Parkway construction, camera facing west toward Main Avenue (Connecticut State Library, Merritt Parkway Construction Collection). **APPENDIX C: Photographs**

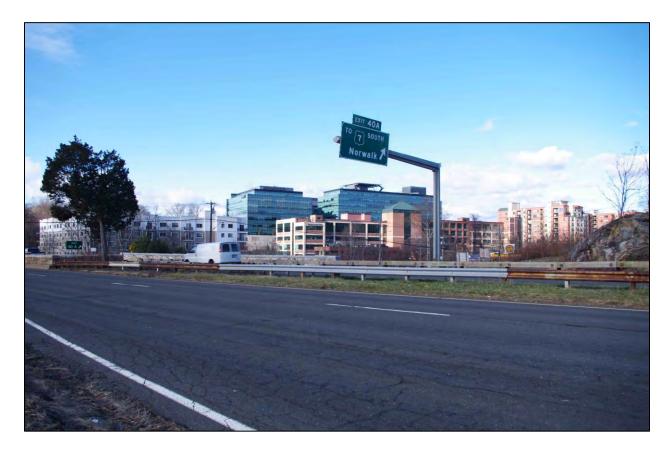
Photograph 2: Merritt Parkway immediately west of Main Avenue Bridge (Bridge Nos. 530A and B), camera facing west towards the Merritt 7 office complex.

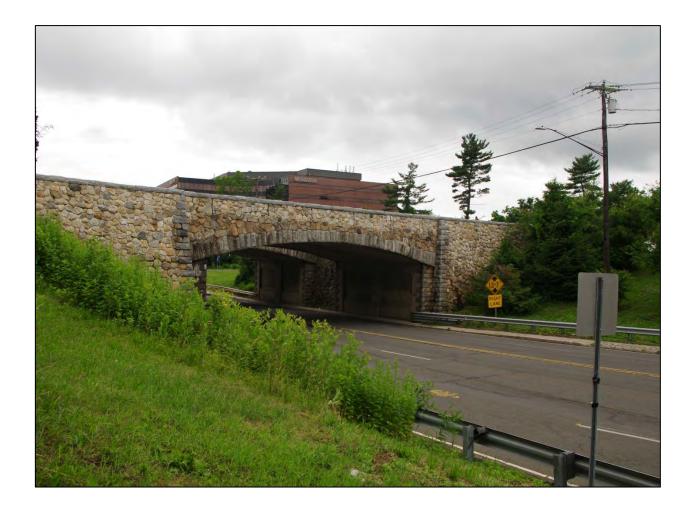
Photograph 3: Merritt Parkway Main Avenue Bridge (Bridge Nos. 530A and 530B), camera facing south.

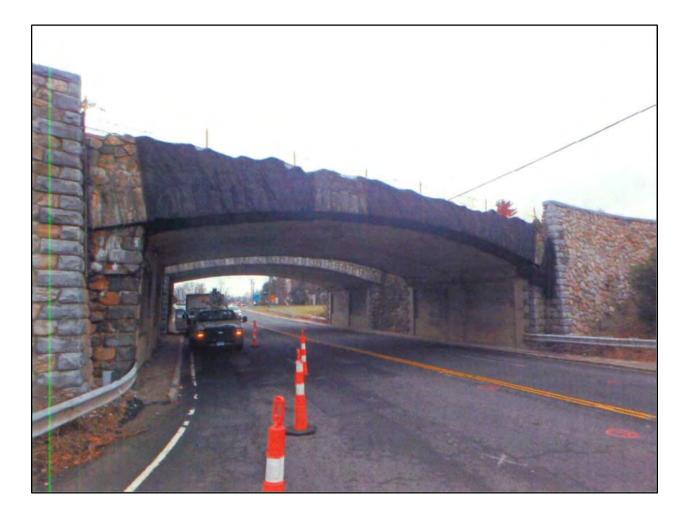
Photograph 4: Merritt Parkway Main Avenue Bridge (Bridge Nos. 530A and 530B) with protective netting, prior to the recent repairs (CTDOT Bridge Inspection photo, December 2014), camera facing south.

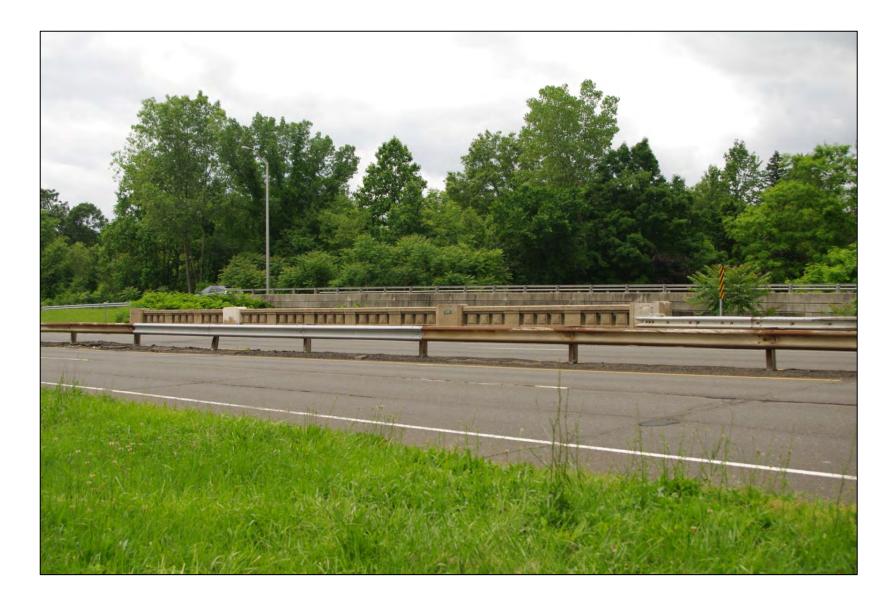
Photograph 7: Western end of APE, vicinity of Perry Avenue undergrade bridge, camera facing northwest. Northbound travel lane in foreground, guiderail, southbound travel lane, north parapet of Perry Avenue Bridge, and Route 7 Southbound-to-Parkway Southbound ramp.

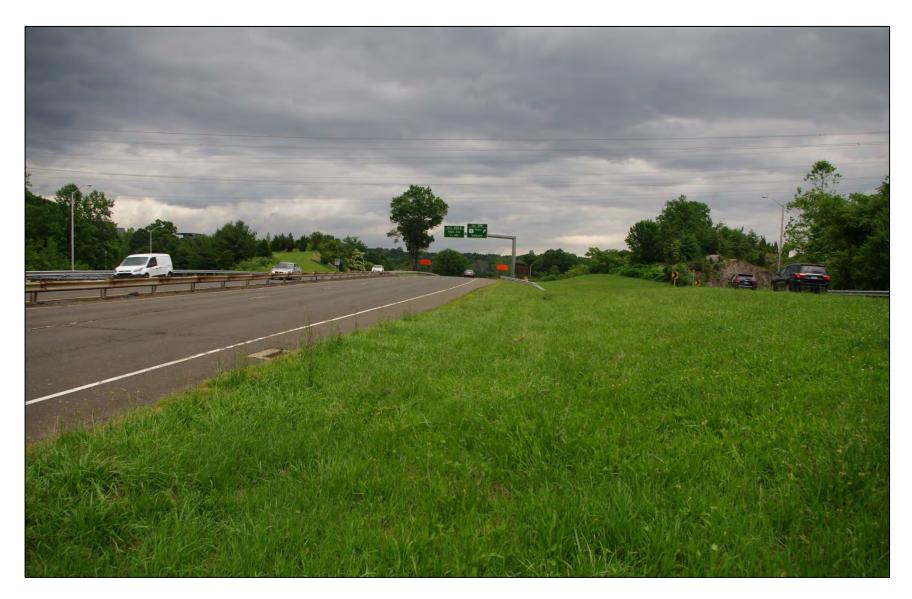
Photograph 8: Western end of APE, east of Perry Avenue undergrade bridge, camera facing northeast. The Parkway-to-Route 7 Southbound ramp is at the right. In the distance are the signs for upcoming exits.

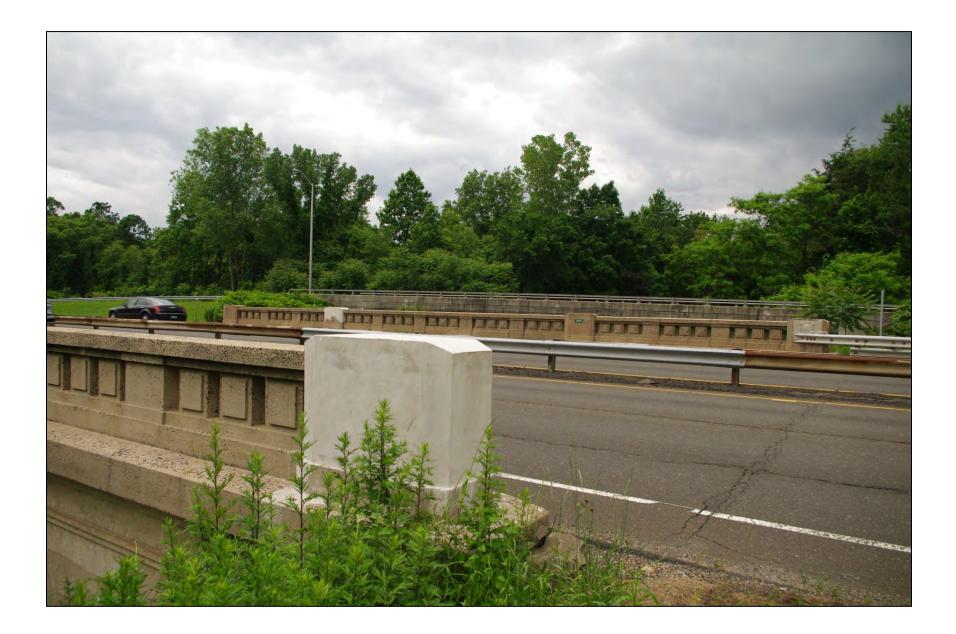
Photograph 9: Parapets of Perry Avenue undergrade bridge, camera facing northwest.

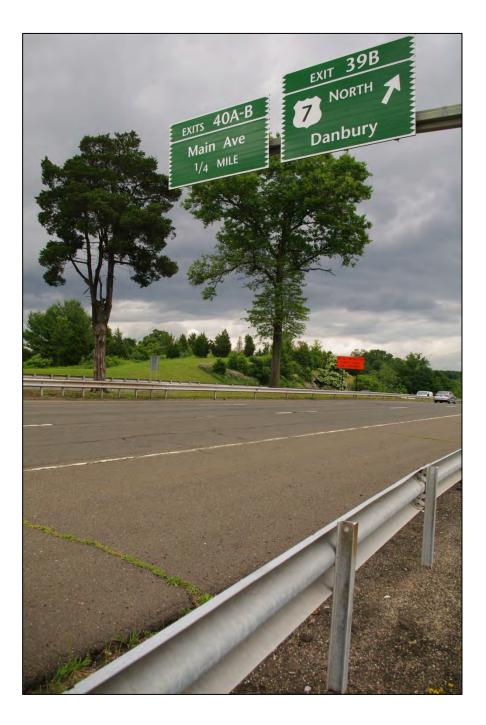
Photograph 11: Character of the Parkway approaching the Route 7 Northbound exit, camera facing northeast. The median widens out enough for some large trees and grassy areas. The paved shoulder widens at this point for a short exit lane. The grassy knoll in the background is part of the outcropping where the Route 7 Southbound ramp enters the Parkway's southbound travel lanes.

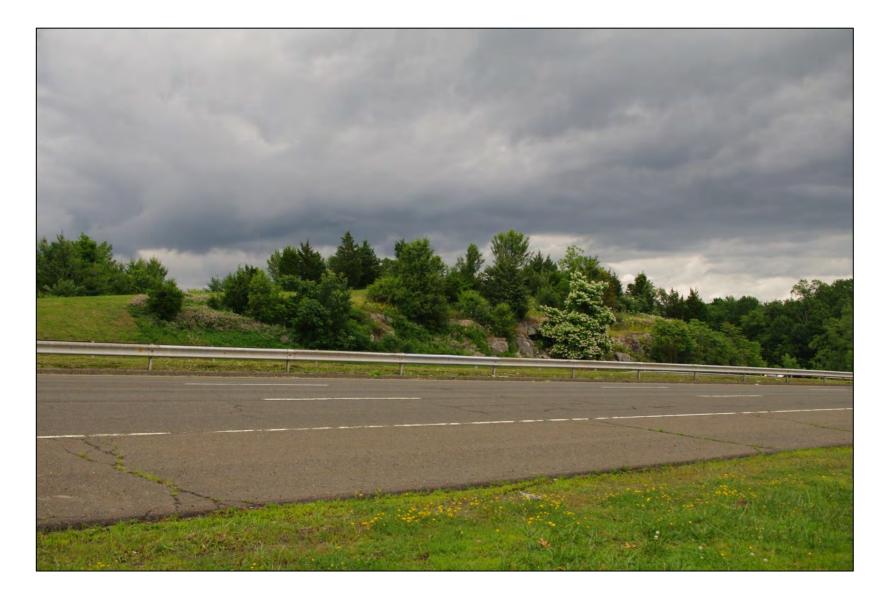
Photograph 12: The rock outcropping where the Route 7 Southbound on-ramp merges with the Parkway's southbound travel lanes, camera facing north.

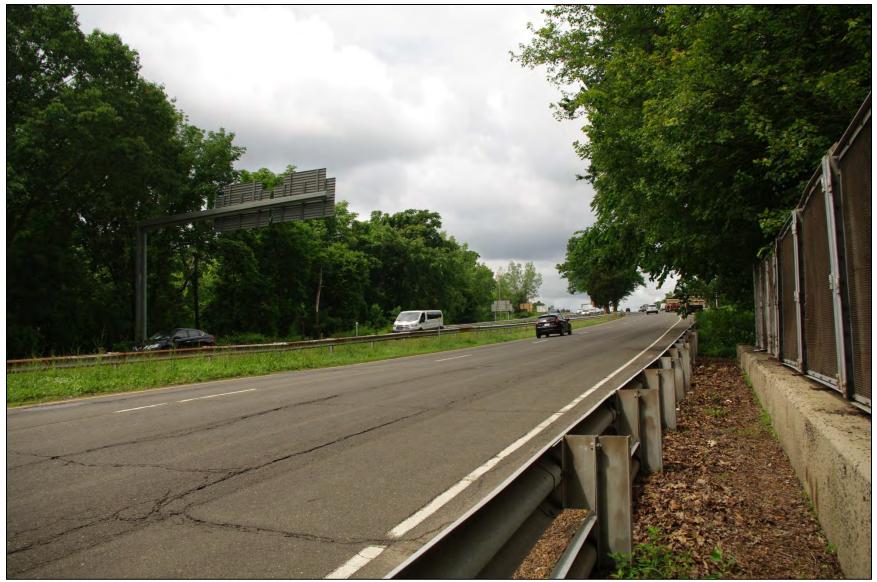
Photograph 14: The character of the Parkway between the ramps for Route 7 and the ramps for Main Avenue, camera facing southwest. The concrete parapet surmounted by metal screening on the right marks the location of the Metro-North bridge.

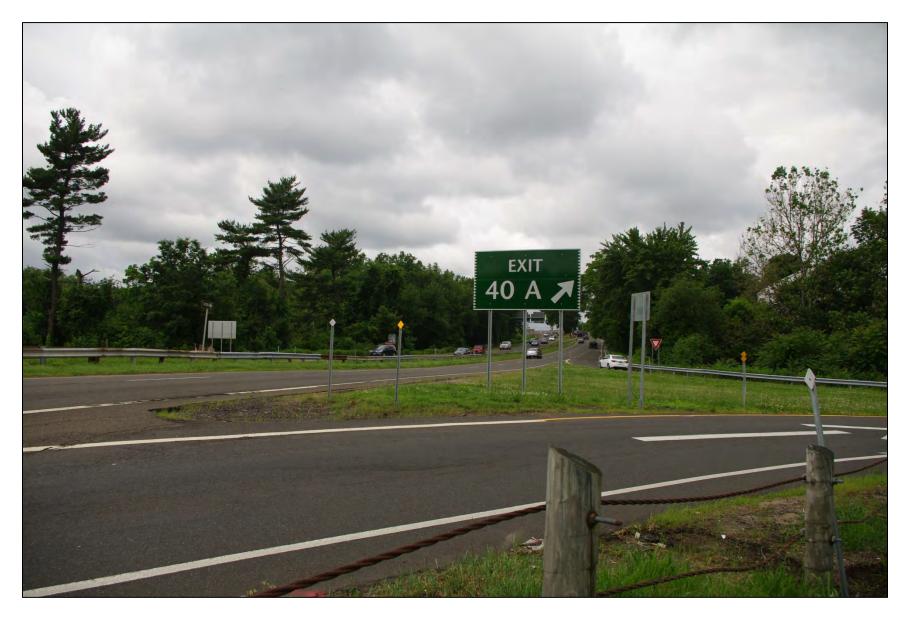
Photograph 16: Reproduction rustic sign and directional reflectors for the Main Avenue exit from the Parkway's northbound lanes, camera facing east.

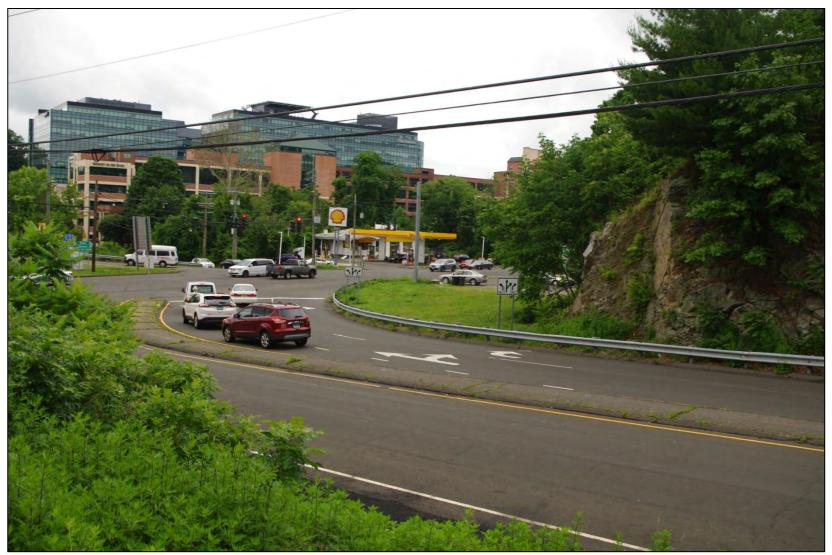
Photograph 20: On-ramp and off-ramp in the northeast quadrant of the interchange of the Parkway and Main Avenue, camera facing northwest, showing paved median, modern guiderail, and overgrown vegetation.

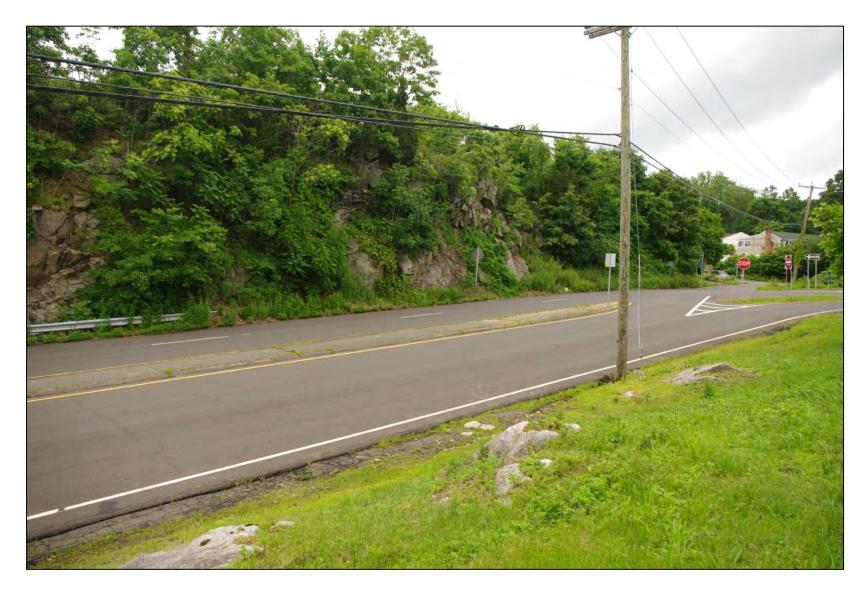
Photograph 21: Rock cut where the on-ramp and off-ramp in the northeast quadrant join Creeping Hemlock Drive, camera facing northeast.

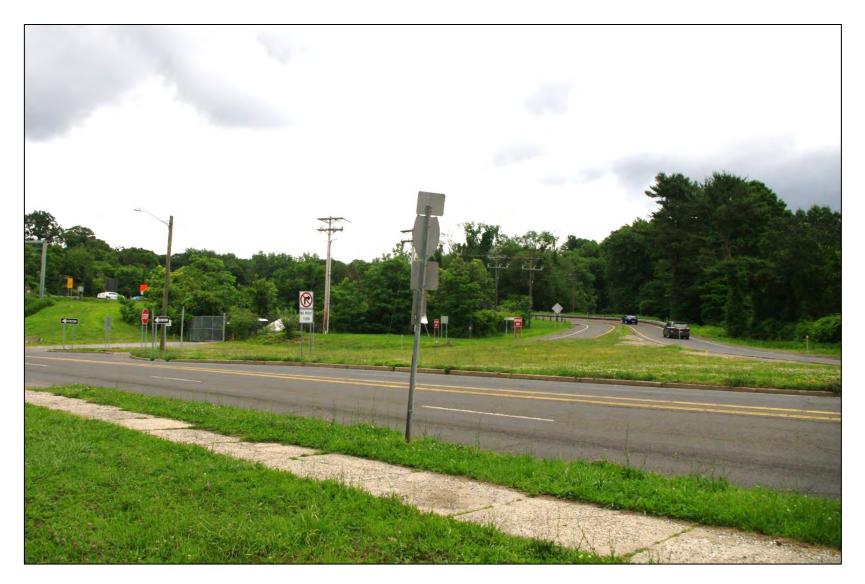
Photograph 22: Overview of the southeast quadrant, camera facing northeast, showing overgrown inner circle (with construction staging area) and east edge, post-and-cable and modern metal guiderail, and power transmission line.

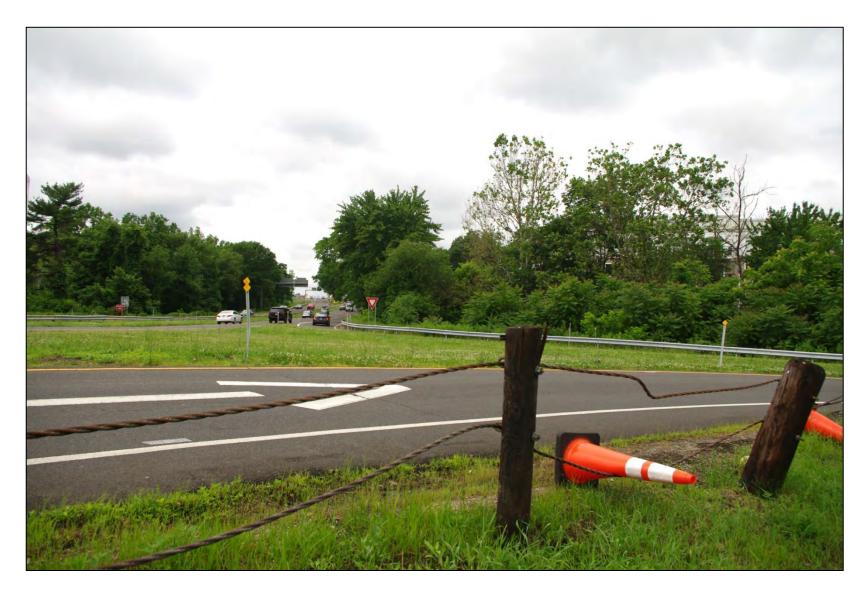
Photograph 28: The grassy triangle at the Parkway end of the ramps in the northwest quadrant, camera facing southwest.

two ramps is grassy (Photograph 28). Guiderail systems include post-and-cable, modern metal, and Jersey-barrier types.

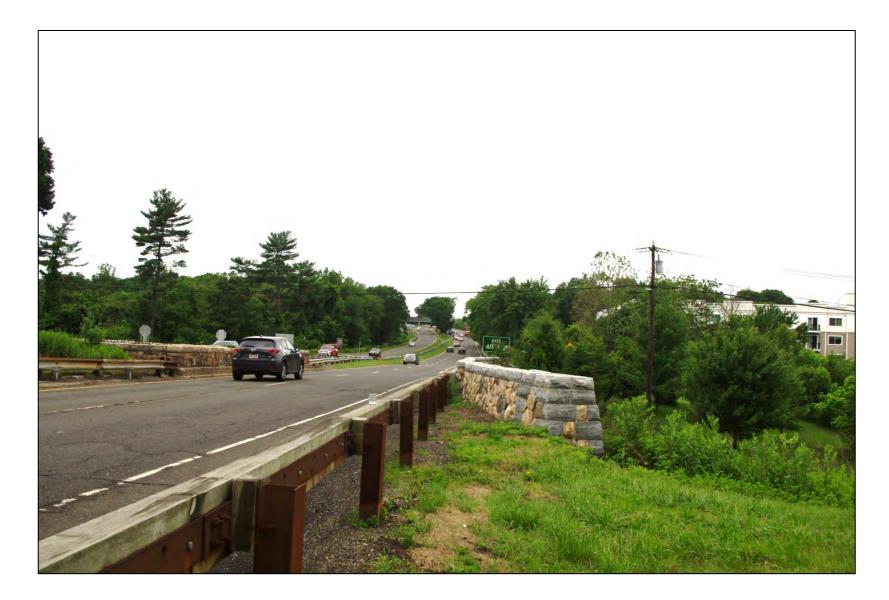
Photograph 31: Detail of the latest timber-on-metal guiderail, joining up with the parapets of the Main Avenue Bridge, camera facing southwest.

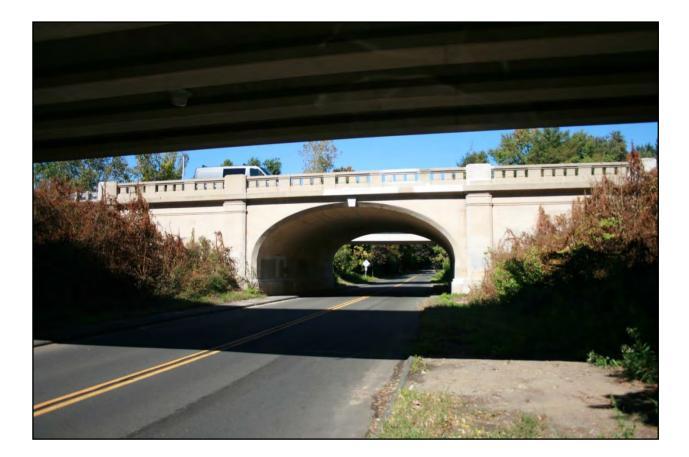
Photograph 32: Merritt Parkway Perry Avenue Bridge (Bridge No. 719), camera facing north.

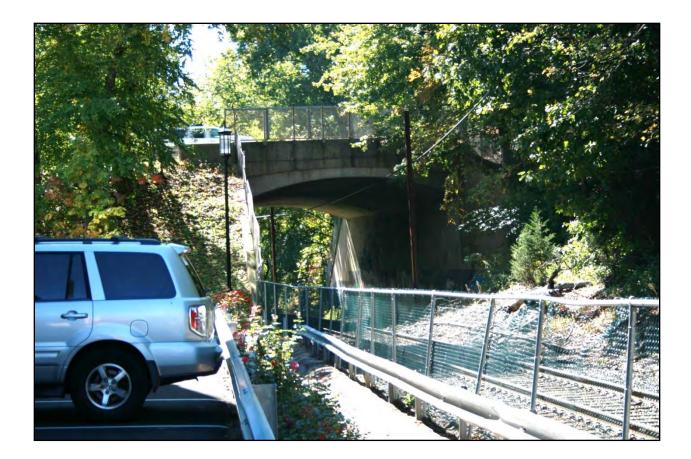
Photograph 33: Merritt Parkway Metro-North Railroad Bridge (Bridge No. 720), camera facing south.

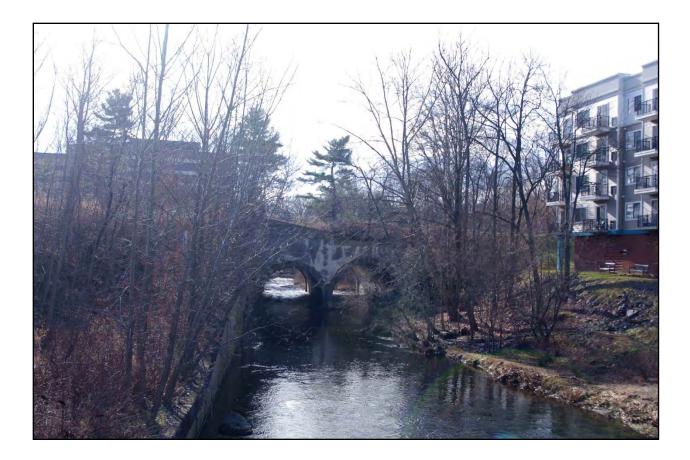
Photograph 34: Merritt Parkway Norwalk River Bridge (Bridge No. 721), camera facing south.

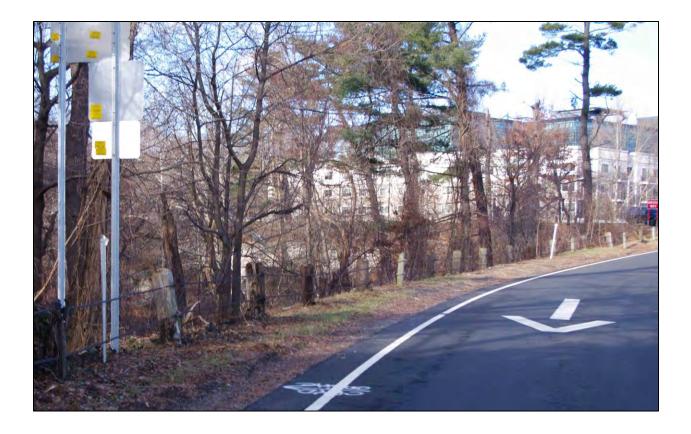
Photograph 35: Northbound exit ramp to Main Avenue, showing the lack of visibility of the Norwalk River Bridge, camera facing north.

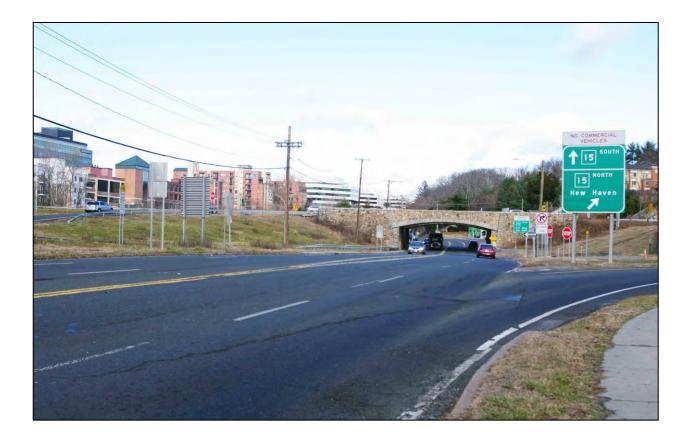
Photograph 36: Main Avenue and Merritt Parkway Main Avenue Bridge (Bridge Nos. 530A and 530B), camera facing north.

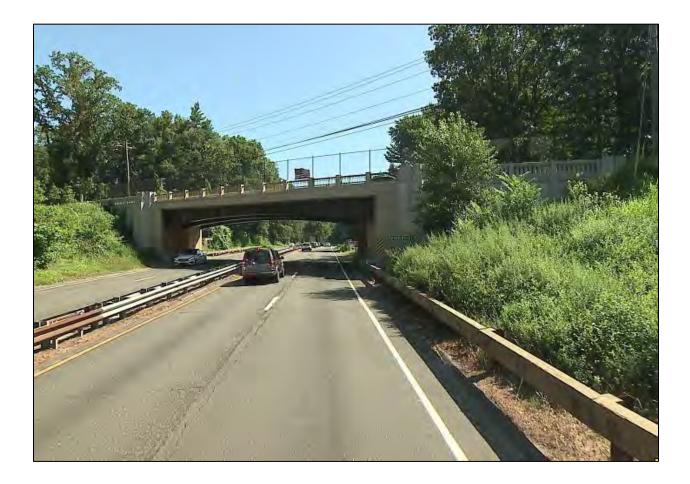
Photograph 37: West Rocks Road Bridge (Bridge No. 722), east elevation, camera facing west (CTDOT photograph, 2013).

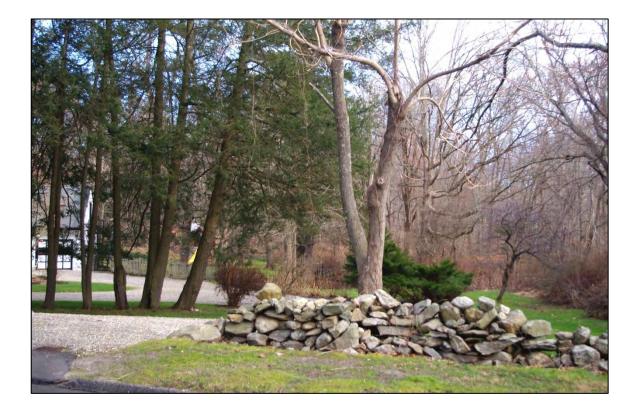
Photograph 39:View towards the Merritt Parkway from Perry Avenue in the<br/>Verneur Pratt Historic District, camera facing east.

- The buildings in the district face westward toward Perry Avenue. The setting of the buildings is defined much more by the stone walls, lawns, and vegetation along Perry Avenue than by the wooded areas that border the rear property lines.
- Field inspection in January 2019, when leaves were off the trees, indicated that no part of the current interchange nor the power line to the west of the current interchange was visible from Perry Avenue in front of the two properties in the district, 114 and 116 Perry Avenue (Photographs 38 and 39).
- Even if visible from the rear portions of the properties, the new elements of the interchange would be only marginally more visually intrusive than the existing power line and highway.

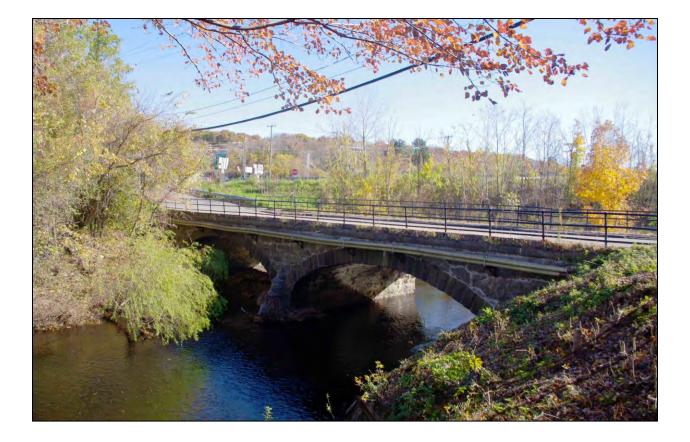
Photograph 40: Glover Avenue Bridge (Belden Hill Avenue Bridge, Bridge No. 4155), camera facing southeast.

The Glover Avenue Bridge (also known as the Belden Hill Avenue Bridge) is a two-span, stone-arch bridge over the Norwalk River (Photograph 40). It has been determined by CTSHPO to be individually eligible for inclusion in the NRHP under Criterion A and C (Clouette and Roth 1991). Built by the City of Norwalk in 1912, the bridge is rubble fieldstone with brownstone voussoirs and coping. A brownstone dedication plaque on the south side of the bridge deck lists the date along with the names of city officials and engineers. Alternatives 12A, 20B, 21D, and 26 would replace the bridge, resulting in a direct adverse effect. State-level documentation of this bridge was completed in 2000.

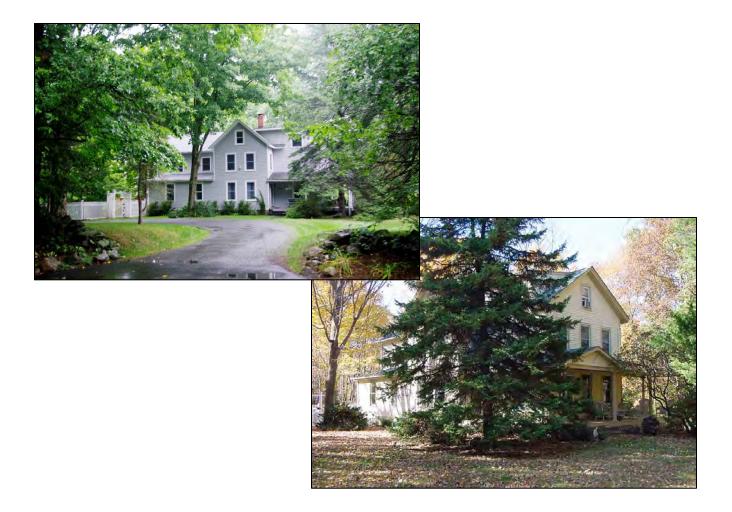
Photographs 41a and 41b: House at 2 Singingwoods Road, camera facing north and northwest. The house is currently painted gray; the earlier assessor's photograph (right) is included as vegetation precluded a current view from Perry Avenue.

19<sup>th</sup>-century house, 2 <sup>1</sup>/<sub>2</sub>-stories high with a cross-gable roof and L-shaped porch (Photographs 41a and 41b). It has clapboard siding and 1-over-1 windows. It has been altered with additions, including a two-story shed-roofed addition on the south side. The property has been identified as potentially NRHP-eligible under Criterion A by CTSHPO, subject to further research.

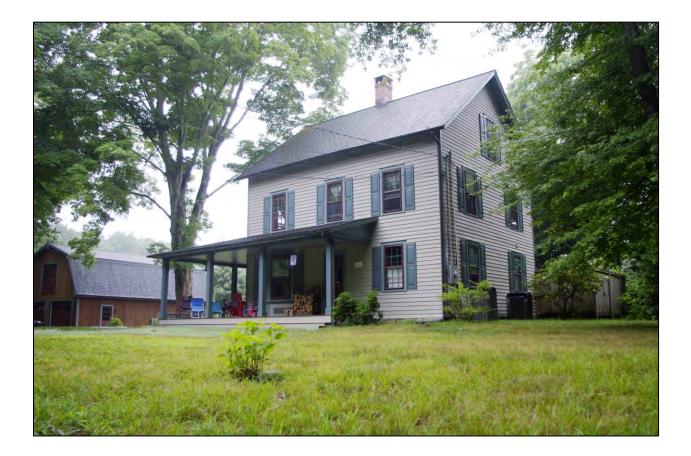
Photograph 42: House and garage at 129 Perry Avenue, camera facing southwest.

This property is located about one-eighth mile north of the Verneur Pratt Historic District. Perry Avenue is a suburban street with widely spaced houses of varied periods, many with deep setbacks, stone walls or fences, and/or heavily wooded lots. The house was built in 1850, according to the Norwalk Assessor's database, and that year is shown on the house's date plaque. While assessor's construction dates for pre-20<sup>th</sup>-century buildings are often not precise, it is a mid-19<sup>th</sup>-century house, 2 <sup>1</sup>/<sub>2</sub>-stories high, three bays wide and two bays deep, with a side-gable roof, clapboard siding, and L-shaped porch (Photograph 42). It has 6-over-6 windows with modern paneled wood shutters. The gambrel-roofed two-bay garage appears to be modern. The property has been identified as potentially NRHP-eligible under Criterion A by CTSHPO, subject to further research.

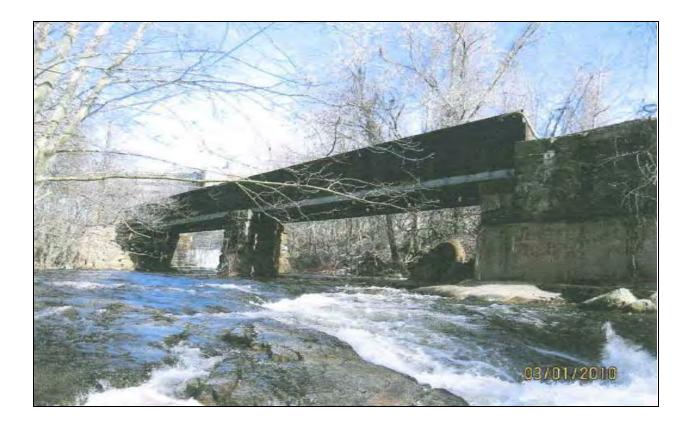
# Photograph 43: Metro North Norwalk River Bridge (No. 8202R), camera facing southwest.

The Metro North Norwalk River Bridge is located on a rail line adjacent to a commercial area, near the north end of Pearl Street on the west side of Main Avenue. Built in 1905, it is a twospan steel plate-girder bridge supported by stone masonry abutments and pier (Photograph 43). While the bridge appears to retain historic integrity, it is a relatively common railroad bridge type and does not appear to rise to the level of individual NRHP eligibility. However, it could contribute to a potential linear historic district along the former Danbury & Norwalk line under NRHP Criteria A and C. Recent consultation with CTSHPO has confirmed that the bridge is potentially eligible.

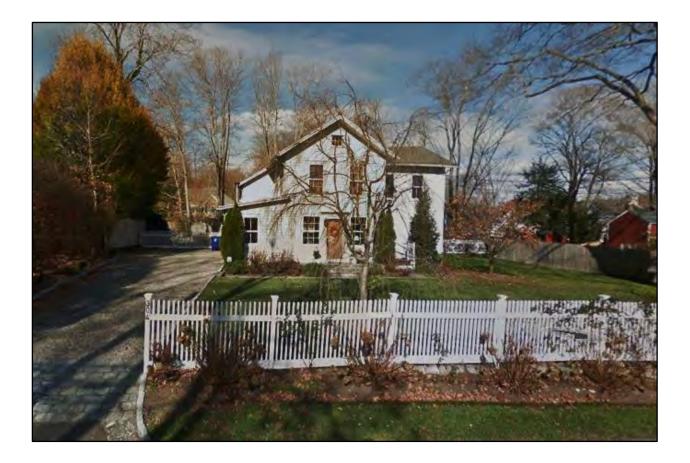
Photograph 44: House at 304 Silvermine Avenue, located in the Silvermine Center Historic District, camera facing north.

The Silvermine Center Historic District is centered around the Silvermine Tavern (194 Perry Avenue) and includes approximately 85 historic buildings in Norwalk, New Canaan, and Wilton. It was listed in the NRHP in 2009 under Criteria A and C (Esser and Graziano 2008). The area first developed in the late 18<sup>th</sup> and early 19<sup>th</sup> centuries around several small mills. As the community grew the tavern and other enterprises were established to serve the small community. The area declined after the mills failed during the latter half of the 19<sup>th</sup> century, but it was revived by a group of artists and writers in the early 20<sup>th</sup> century. It evolved into a thriving artists' colony that is still represented by the Silvermine Guild of Artists and the Silvermine Arts Center. The area is characterized by small-scale vernacular buildings with Colonial, Greek Revival, and Colonial Revival influences (Photograph 44).
