Routes 7/15 Interchange Norwalk, Connecticut State Project No. 102-358

Environmental Assessment, Draft Section 4(F) Evaluation and Environmental Impact Evaluation

# PUBLIC REPORT PHASE I AND II CULTURAL RESOURCE SURVEYS ROUTE 7/ROUTE 15 INTERCHANGE PROJECT STATE PROJECT NO. 102-358 NORWALK, CONNECTICUT

December 13, 2018 Updated August 24, 2020

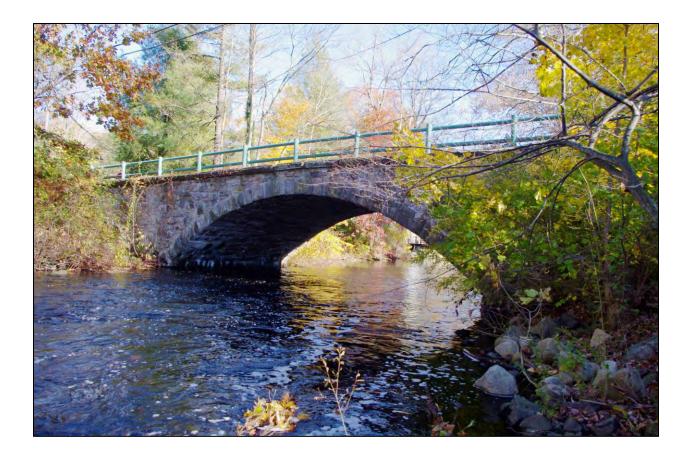
Photograph 45: Perry Avenue Bridge (Bridge No. 4130), camera facing northeast.

The Perry Avenue Bridge carries an east-west section of Perry Avenue over the Silvermine River within the bounds of the Silvermine Historic District. It was listed individually in the NRHP in 2006 under Criteria A and C (Glaser 2005). It is a contributing resource within the Silvermine Center Historic District, which was listed in 2009 (Photograph 45). The single-span, stone-arch bridge was built in 1899 by the City of Norwalk and is a rare surviving example of its type dating from this time period. It is constructed of random rubble-stone, capped with a single course of Portland brownstone that also serves as a curb. A tubular steel railing lines the bridge and dates from before 1920. The district, located about one-quarter a mile west of the APE, will not experience direct or indirect effects; visual impact assessment determined that intervening topography and vegetation visually screens the district from the project.

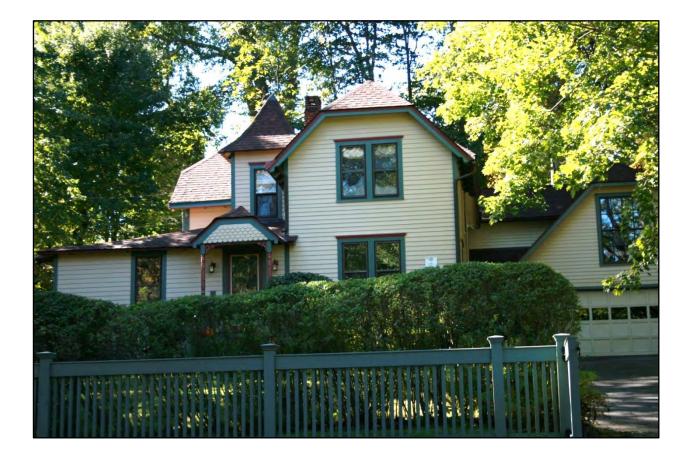
Photograph 46: House at 177 Silvermine Avenue in the Silvermine Avenue Historic District, camera facing west.

The Silvermine Avenue Historic District was formally approved for NRHP study by the CTSHPO in 2009 (Esser 2009), but as of this date has not been acted upon by the State Historic Preservation Board. It includes a collection of approximately 60 residences and ancillary structures (148-285 Silvermine Avenue, 1-2 Silver River Court, and 1-10 Red Barn Lane) significant under Criteria A and C. Development of the area began with small, agrarian-based industry along the banks of the Silvermine River in the 18<sup>th</sup> century. Silvermine Avenue served as the main market road between Norwalk and Silvermine during the 19<sup>th</sup> century. The area continued to develop at a steady pace in the beginning of the 20<sup>th</sup> century, with the construction of major roadways such as Route 7 and the Merritt Parkway making it an attractive bedroom community. The architecture reflects this pattern of development and includes Colonial, Victorian, Greek Revival and Colonial Revival-style houses (Photograph 46). The district, located about one-eighth of a mile west of the APE, will not experience direct or indirect effects; visual impact assessment determined that intervening topography and vegetation visually screens the district from the project.

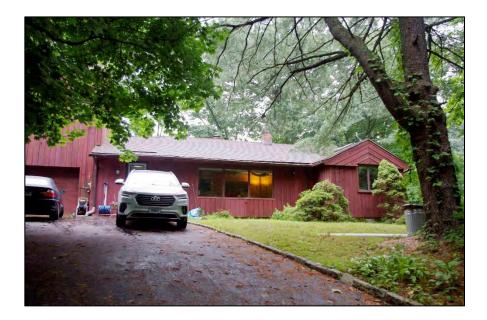
Address: 36 LINDEN ST Map/Block/Lot/Unit: 5-21-272-0

Year Built (Assessor): 1952 Description(Assessor): Ranch; altered with two-story garage addition and vertical wood siding

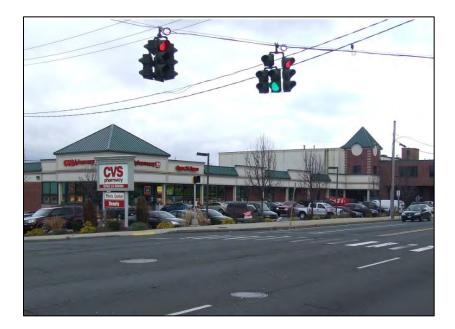
The former Clover Mfg. Co. complex has been developed as a commercial plaza (below). Only one portion, a ca.1940 storage building (right), retains an industrial appearance (the windows are replacements).

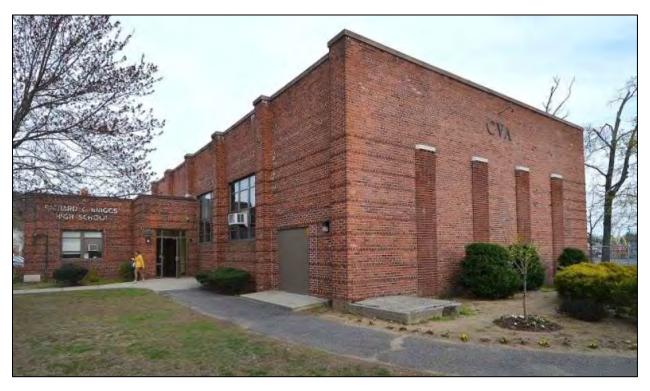
Year Built (Assessor): 1937 Description(Assessor): Schools-Public; masonry/concrete

The earliest part of this school was built in 1937 because the original Winnipauk school lot was in the path of the Merritt Parkway. Additional parts of the complex were added in 1973, 1989, and 1992. Currently it is used as a vocational-arts high school (Briggs High School).

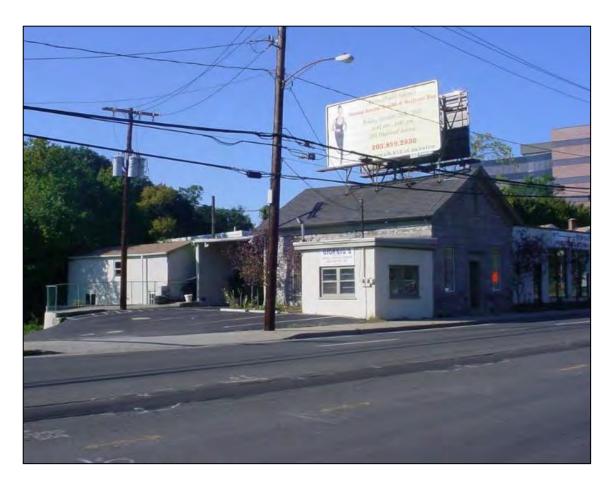
Year Built (Assessor): 1951 Description(Assessor): Light Indust; masonry/concrete

This property includes the single surviving remnant of the Winnipauk Mills, the small stone office building, which itself has become embedded within modern additions on three sides.

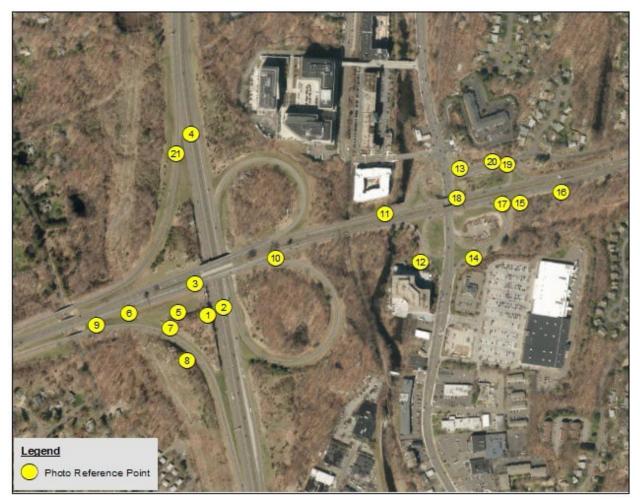
Figure 1.1 Existing Conditions Photo Locations

The following photographs depict both positive and negative attributes of the existing Merritt Parkway and adjacent access and egress ramps in the project area. Photo locations are depicted in **Figure 1.1**.

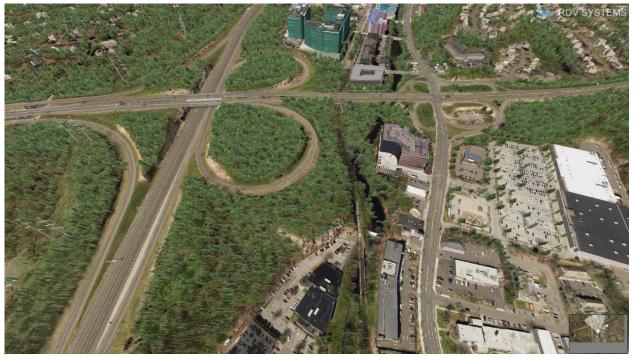
Figure 3.1 Design Criteria - Existing Condition

These criteria establish a framework for the assessment of existing site conditions and the two Build Alternatives in the context of the Merritt Parkway's historic landscape character. In doing so, this assessment acknowledges contributing landscape elements within the District that have retained their integrity in the context of significant change that has occurred within the project

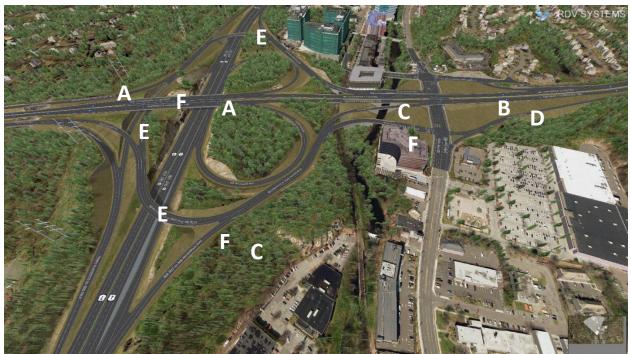
Figure 3.2 Design Criteria - Alternative 21D

#	Resource	Impacts
А	Views	Lane encroachment diminishes Parkway experience
		Footprint of ramps fragment landscape
		Distant landscape views from Parkway are diminished
В	Vegetation and planting design	Width of roadside adequate for planting and creating and/or maintaining naturalized landscape character
С	Topography	Built road-sides transition to naturalized landscape
		Steep slopes limit planting impact
D	Aesthetic Rehabilitation	Rehabilitate remnant, scarred and cluttered right-of-way areas to enhance Parkway character
Е	Circulation	Roadway footprint diminishes Parkway character
F	Natural features	Landscape reveals natural resources (watercourses, woodlands, rocky ledge)

area over the past five decades. This assessment also acknowledges each design alternative's potential to satisfy these criteria. For this assessment, the no-build condition is represented by the current condition, depicted in Figure 3.2. Figure 3.3 and Figure 3.4 depict the location of selected impacts for Alternatives 21D and 26 to supplement the following discussion of impacts. Each figure is followed by a table that lists selected impacts whose locations are shown by letter references in the figures.

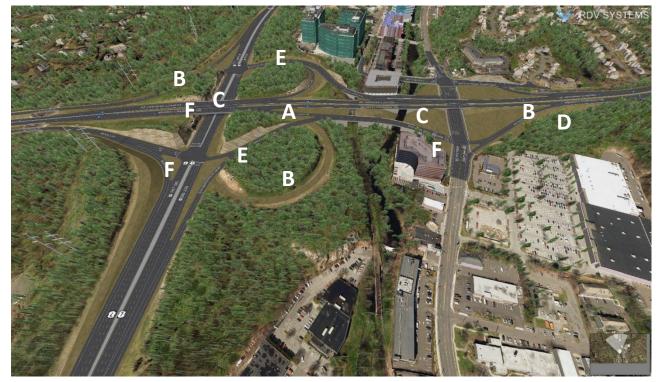
Figure 3.3 Design Criteria - Alternative 26

#	Resource	Impacts
А	Views	Lane encroachment diminishes Parkway experience
		Compact alignment limits structures in Parkway viewsheds
В	Vegetation and planting design	Width of roadside adequate for planting and creating and/or maintaining naturalized landscape character
		Preserves existing vegetation that provides aesthetic, buffering, and park-like values
С	Topography	Built road-sides transition to naturalized landscape
		Steep slopes limit planting impact
D	Aesthetic Rehabilitation	Rehabilitate remnant, scarred and cluttered right-of-way areas to enhance Parkway character
E	Circulation	Roadway footprint does not diminish existing Parkway character
F	Natural features	Landscape reveals natural resources (watercourses, woodlands, rocky ledge)

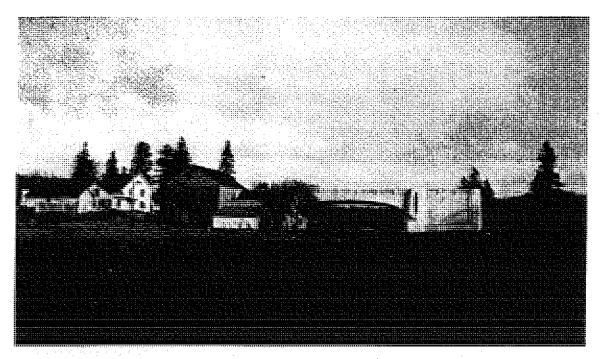
# Easton Turnpike Bridge Formerly "Sport Hill Road" Bridge *Fairfield, CT 1939*

Looking east with the bridge complete and entirely free standing at this time. The farm house was moved to another location and the barn was razed.

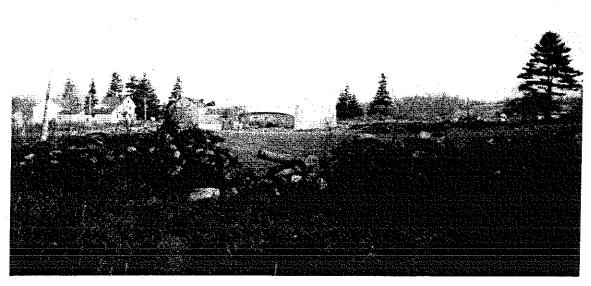
# Easton Turnpike Bridge Formerly "Sport Hill Road" Bridge *Fairfield, CT 1939*

Looking east from further back on the base line for the future Parkway. Notice that much of the land was farmland or meadow. The project landscape architects estimated that probably 50% of the land was open or in wetlands.

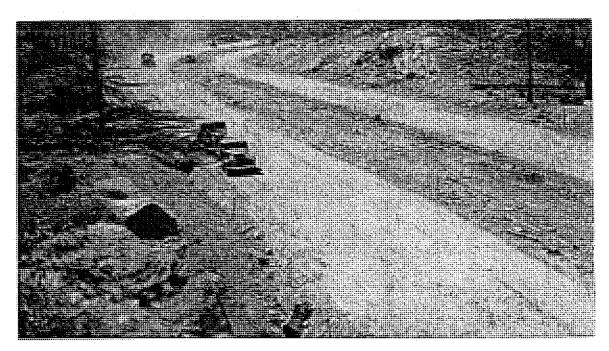
# Near New York State Line Greenwich, CT 1936

One mile east of the New York state line, the rock has been excavated and the road is rough graded. The areas in Greenwich tended to be more wooded than the remainder of the Parkway but were still almost 50% open.

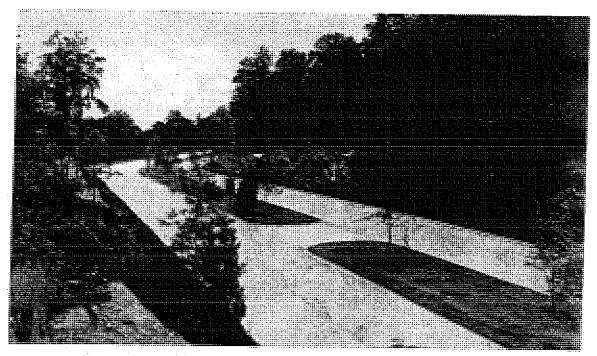
# Near New York State Line Greenwich, CT 1939

The same view three years later. The standard wood guiderail is barely visible on the distant curve. Many crossovers existed initially but were later closed for safety reasons. Casual picnicking was also stopped.

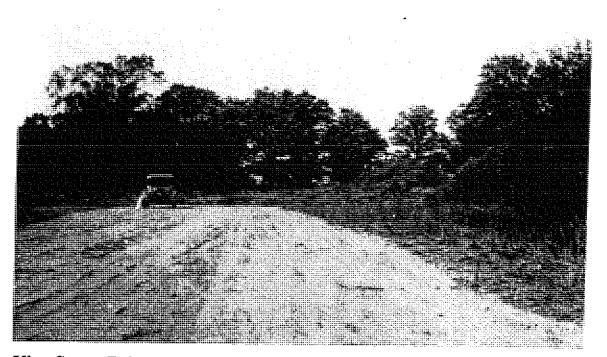
King Street Bridge Greenwich, CT 1936 Looking west toward future King Street Bridge and in the direction of the New York state line.

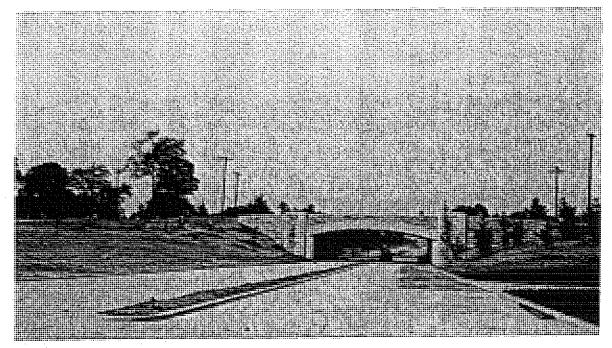
King Street Bridge Greenwich, CT 1938 Looking toward the completed King Street Bridge and New York State beyond. The landscaping is complete on the right and in progress on the left. Note the low concrete curb on all road edges. This has virtually disappeared today as layers of bituminous have been added.

The Merritt's travelways consist of two reinforced concrete pavement strips, each 26 feet in width creating two 13-foot travel lanes from curb to curb. The concrete curbs have almost disappeared over time as subsequent layers of asphalt have been laid down. Crossovers existed initially but were short-lived with only a few remaining for police and maintenance vehicles. The concrete curbs originally were four inches in height and eight inches wide sloping at 45 degrees to almost three inches at the top. The curb also contained the "cat's eye reflector", which was considered a new innovation in the late 1930's.

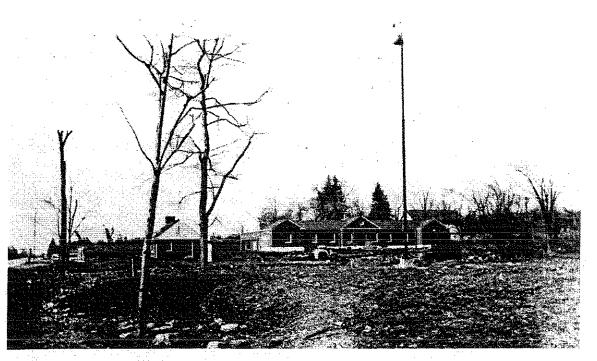
### Gas Station and Maintenance Building New Canaan, CT 1940

The gas station and maintenance building on the north side of the Parkway. The Parkway is barely visible to the left side of this view. The only lighting on the Parkway occurred at the service areas in the form of a high-mast source which seems unique for the times.

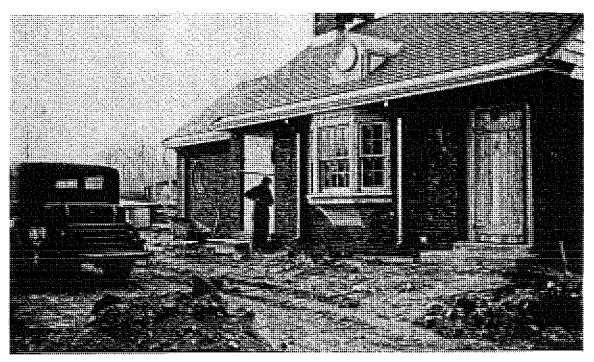
Gas Station and Maintenance Building New Canaan, CT 1940 A close-up of the station shows that the building has been closed in. The "dormer" later housed a clock which exists to this date.

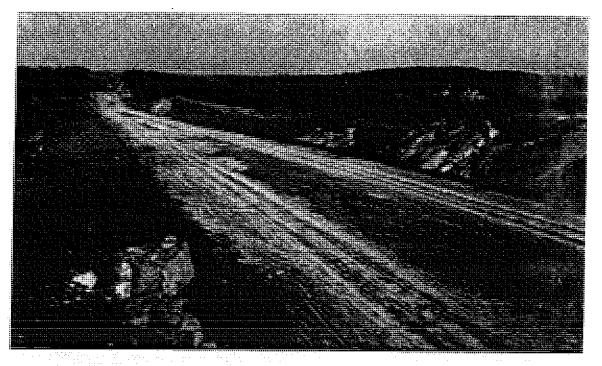
"Ripples Cut" Area Greenwich, CT 1936 Located just east of the New York state line, this area got its name from the series of rock outcrops which occurred with undulating regularity. The road has been subgraded and the cuts and fills have been fine graded and seeded.

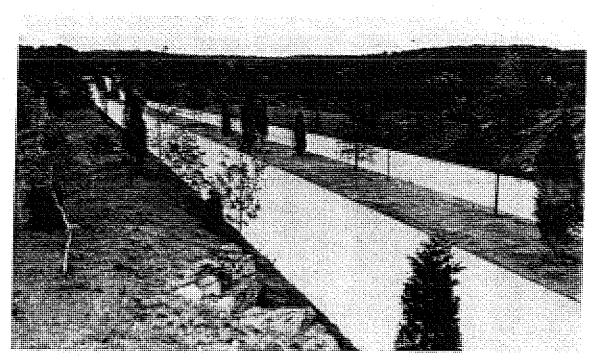
### "Ripples Cut" Area Greenwich, CT 1939

The same view three years later with the road completed and the landscaping installed. Notice the field juniper planted in an open field setting and the close proximity of the trees to the road edge.

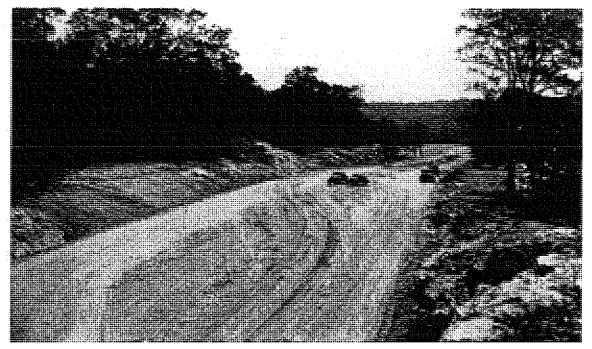
### **Riversville Road Area** Greenwich, CT 1936 Looking west toward Riversville Road, the subgrade has been complete and it appears that topsoiling and fine grading are in progress.

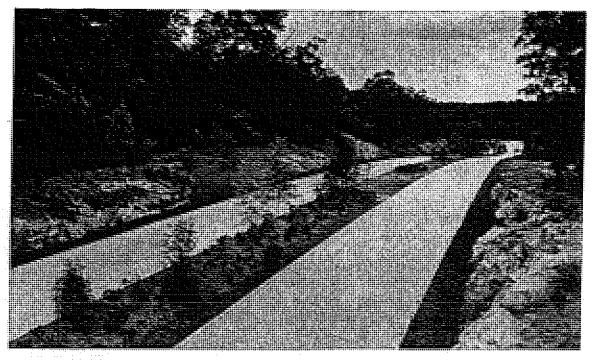
**Riversville Road Area** Greenwich, CT 1939 The same view three years later. Notice the amount of laurel planted in the median. The low planting was to disappear within five years due to road salts and maintenance needs.

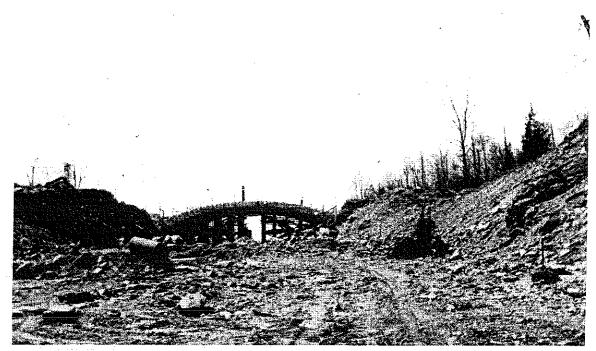
### Guinea Road Bridge Formerly "Rocky Craig" Bridge Stamford, CT 1937 The construction scaffolding is holding up the granite voussoirs with ashlar fieldstone to follow. The rough grading is in progress with many rock outcrops exposed.

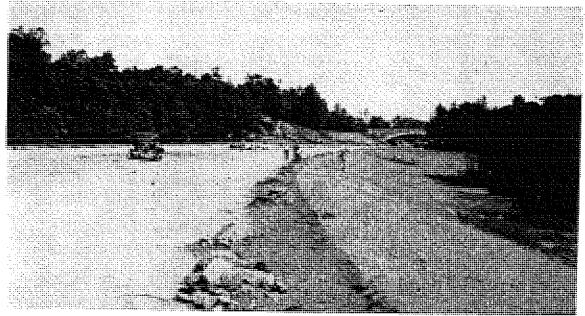
## Guinea Road Bridge Formerly "Rocky Craig" Bridge Stamford, CT 1939

The bridge has been completed and the finished grading is in progress. Notice the soft transition grades at the top and bottom of the slopes as proposed by the State's landscape architects.

> The careful regrading and softening of the no cut - no fill line was requested by the landscape architects and supported by several of the highway engineers (see Item No. 4 above). The plant material removed due to cut and fill was usually replaced with similar species to retain the continuity. Mr. Chase also used a great deal of laurel on the slopes and edges. It was felt that this was "what made the Parkway."

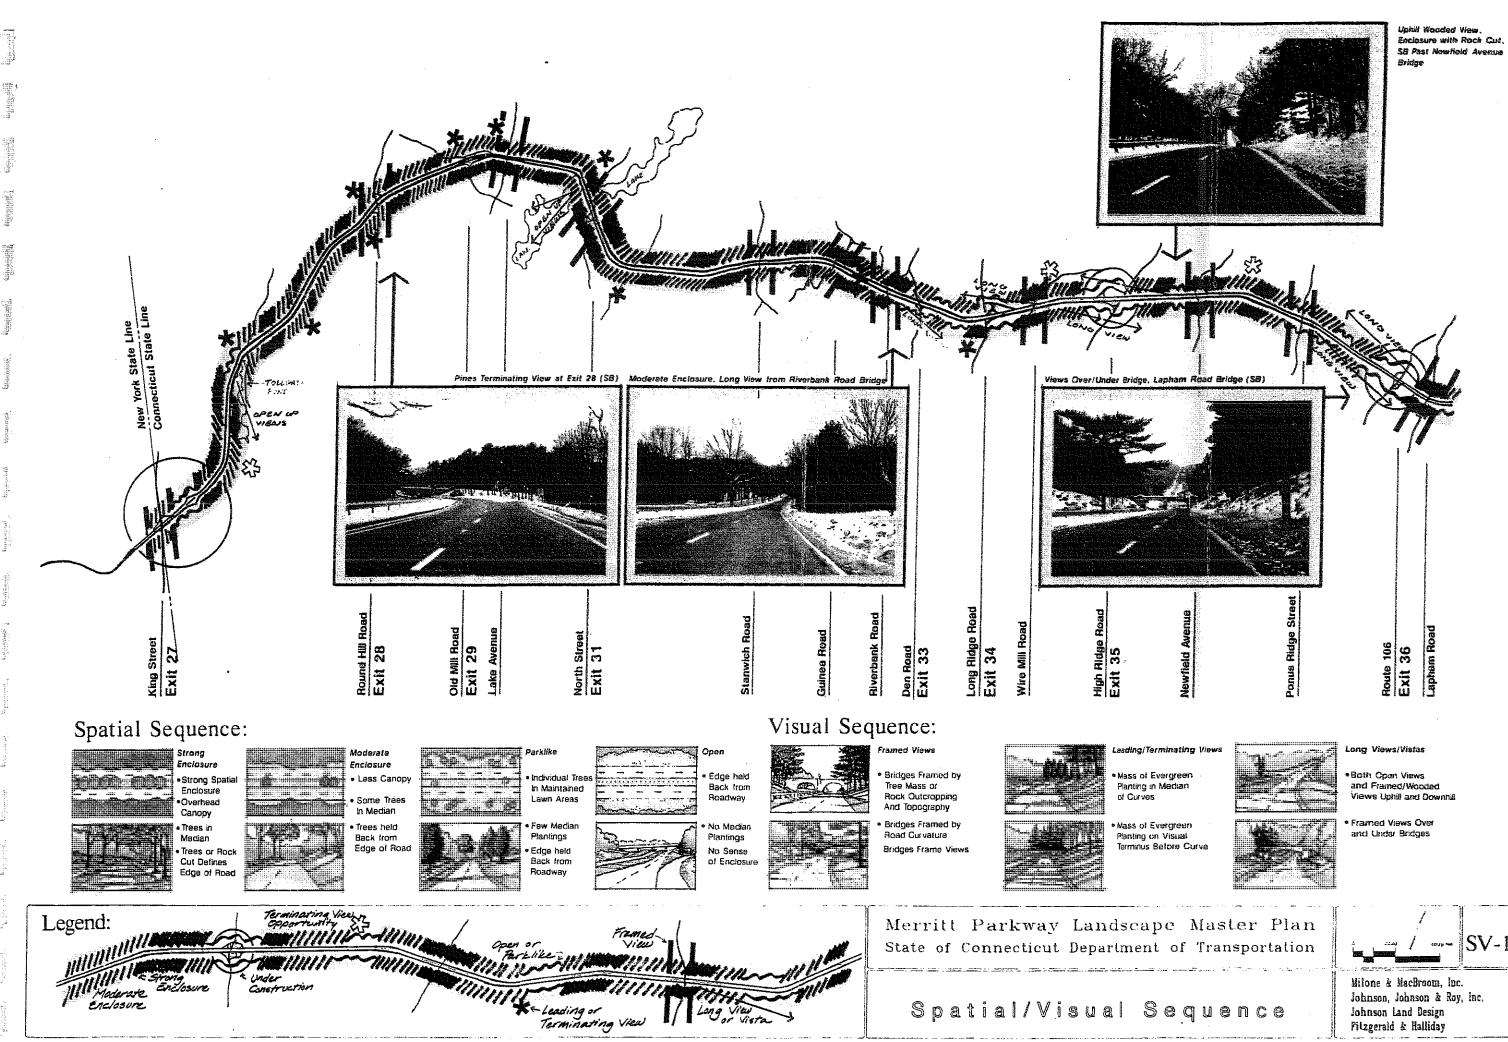
Enclosure with Rock Cut Avenua

- a. *Framed views* where bridges are framed by heavy vegetation, rock outcroppings, and topography sloping toward the road. In some cases, the horizontal curvature of the road contributes to the framing of the view. Grouped plantings adjacent to the bridges represents a typical design technique used at the time of construction.
- b. *Leading or terminating views* where evergreen plantings are located on the median curves leading the driver through the curve. Similarly, evergreens form a visual terminus when planted on the outside edge before the curve.
- c. Long views/vistas typically occur on steep gradients where the motorist is able to see long distances and is limited only by vegetation outlined on the short horizon. In some instances, a framed view over or under a bridge may occur in the foreground.

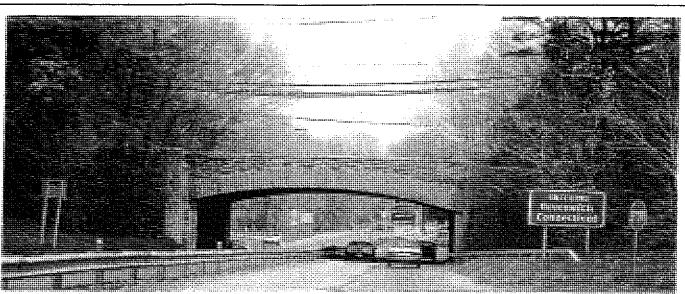
### STATION 000+000

PRIOR TO ENTERING MERRITT PARKWAY, LOOKING NORTHBOUND AT KING STREET BRIDGE (EXIT 27)

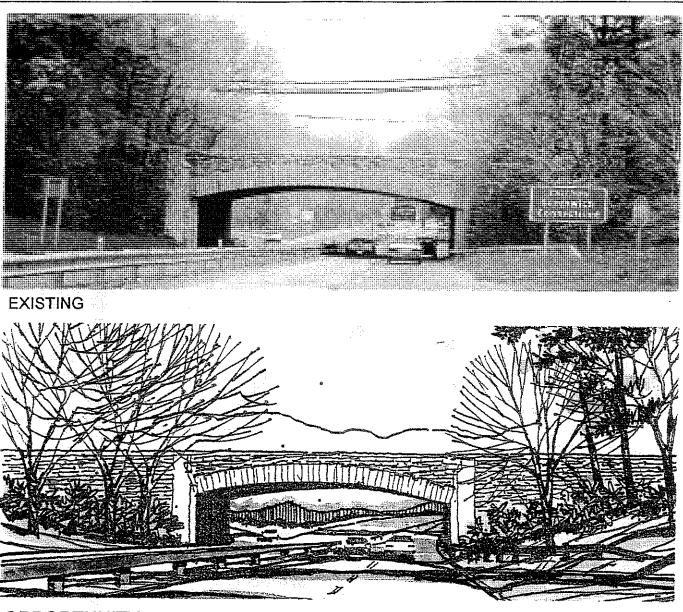
# Gateways Northbound Entrance

Remove invasive growth at bridge; add laurel masses at abutments; relocate distracting signage from abutment and median.

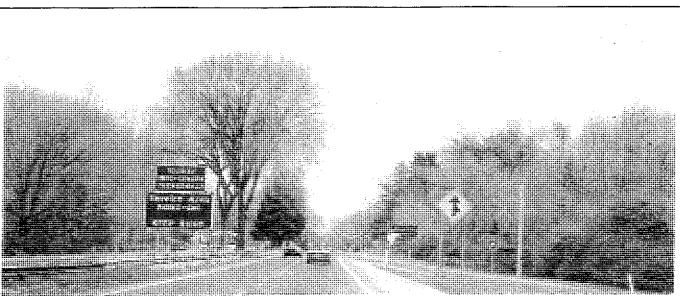
## STATION 000+350 LOOKING NORTHBOUND PAST KING STREET BRIDGE (EXIT 27)

Northbound "Gateway" of Merritt Parkway:

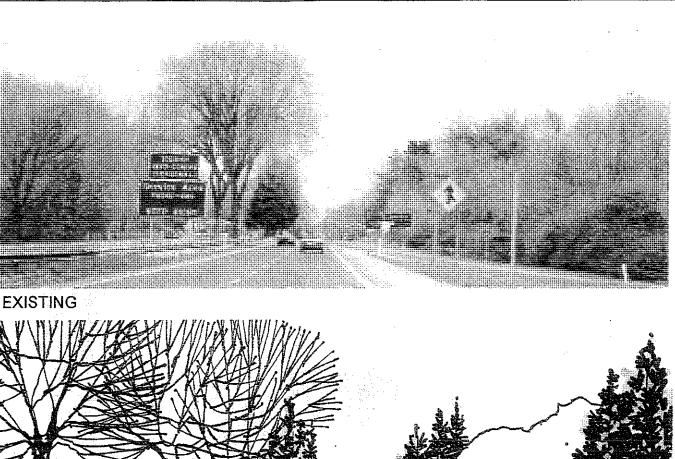
Introduction of Merritt Parkway landscape and its design themes; consolidate signs; addition of median trees and laurel massing for color at edge.

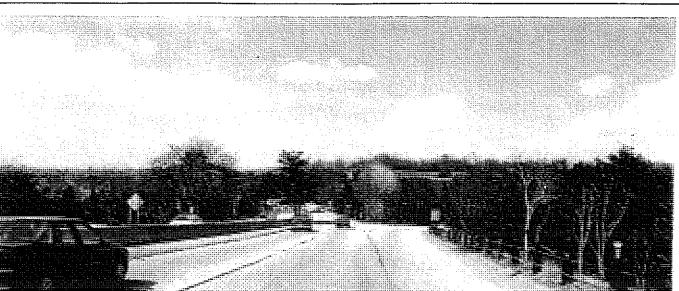
STATION 196+400 LOOKING SOUTHBOUND PAST HOUSATONIC RIVER BRIDGE

- First Parkway identity opportunity from bridge
- Poorly defined landscape character for first mile of Parkway
- Exposed views to buildings on ridge
- Inconsistent median trees and guiderail
- Wide intersection, widened pavement
- Insignificant Parkway identifying signage

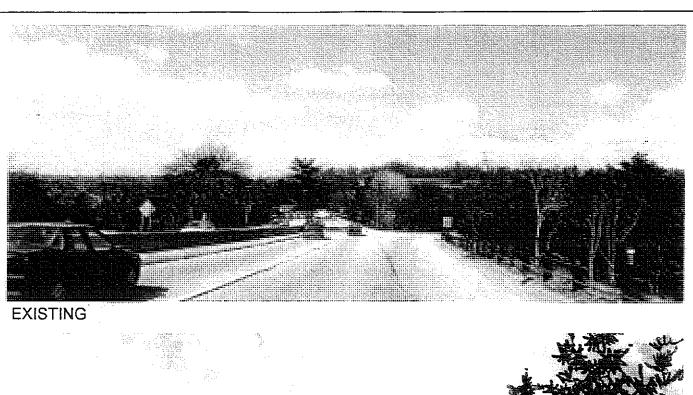
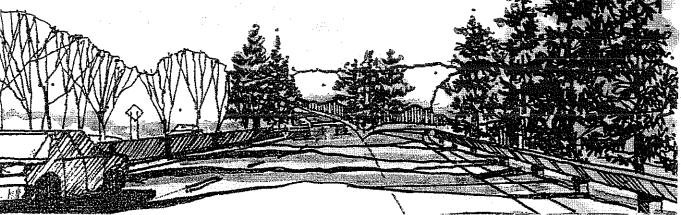
Bring Parkway landscape to edge of roadway; clear invasive vegetation to reveal conifer stand at terminating view; introduce median trees closer to Parkway entrance.

Ability to maintain evergreens in median in this high traffic area (may need to use deciduous species); bringing landscape edge in closer requires additional guiderail.

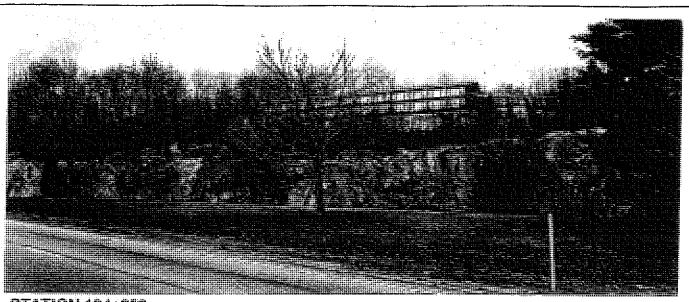
## STATION 194+650 LOOKING FROM SOUTHBOUND LANE TO ROCK FACE

Part of southbound "Gateway" image area:

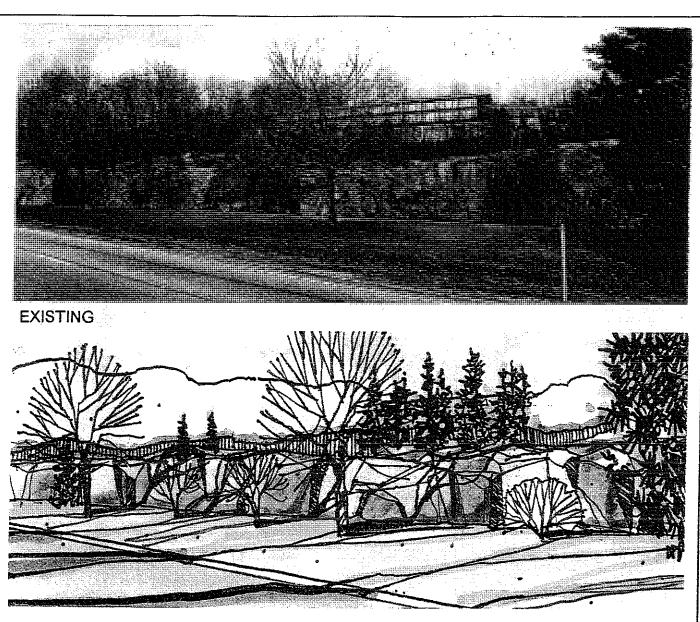
# Gateways Southbound Entrance

Clear invasive vegetation along rock cut and add conifer mass at ridge to screen views; enhance park-like plantings in island.

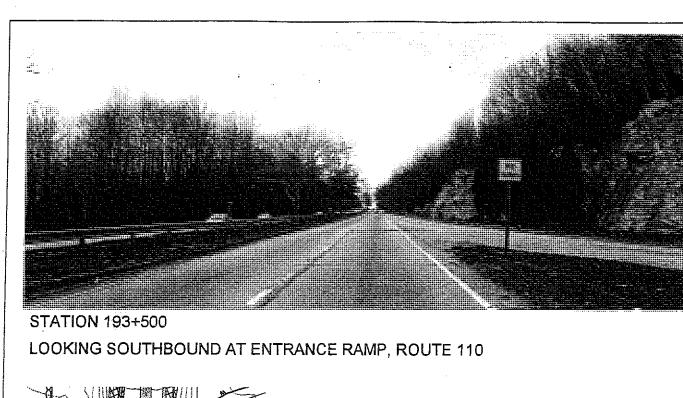
End sequence of southbound "Gateway" image area:

- Transition area from widened interchange to existing wooded enclosure of the Parkway
- Missing median trees need replacement
- Lack of seasonal color (small patches of laure) remain)
- Areas of invasive growth

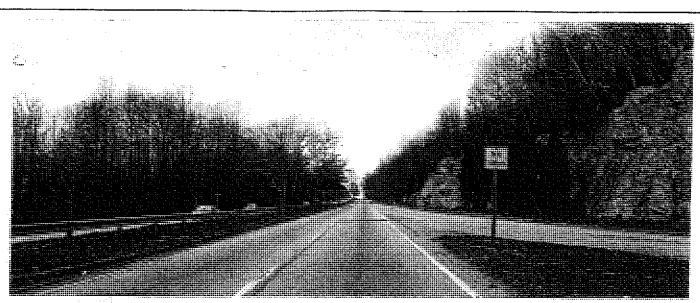
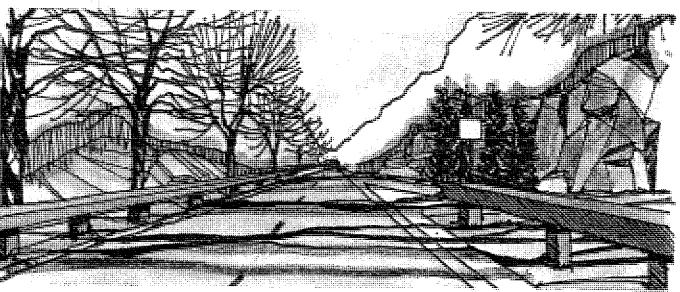
EXISTING.

Add median trees; clear invasive vegetation at rock cut; add laurel mass beyond base of rock cut; install consistent guiderail system.

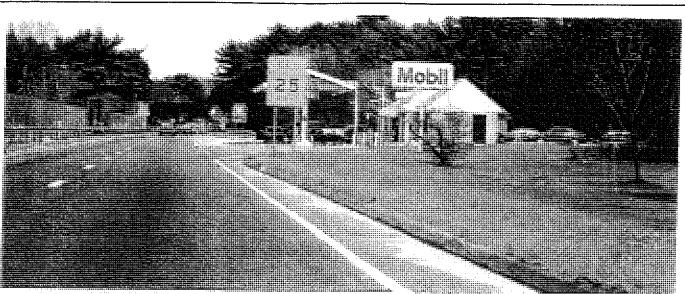
## STATION 149+600 FAIRFIELD SERVICE AREA EASTBOUND, LOOKING EAST

Approach lane to service areas:

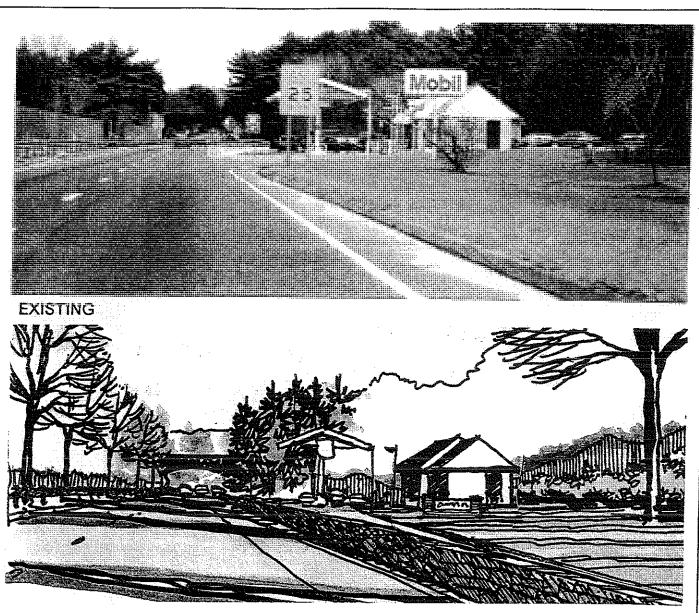
Extend approach lane slightly; add "faux" stone wall guiderail/barrier system at edge.

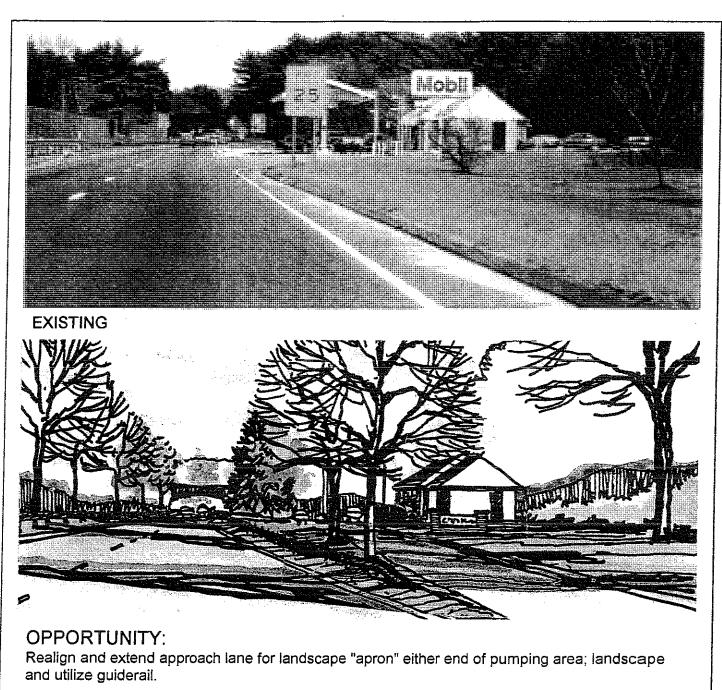
Provides both increased separation of pump area from travel lane and area of landscape continuity either side of service area.

Requires guiderail at pavement edge if trees are planted. Realignment of approach lane should have minimal or no impact on mature tree stands. Transition at terminal of guiderail needed.

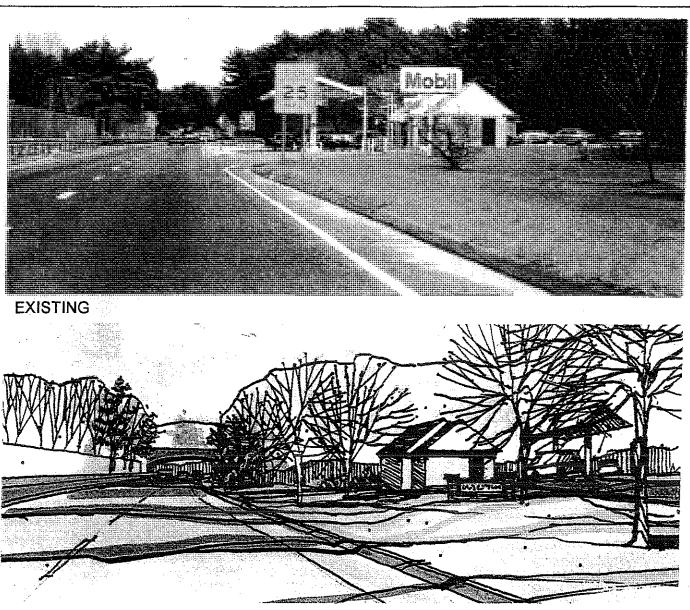
Relocate pumps to rear of service area; create landscaped buffer between service area building and travel lane.

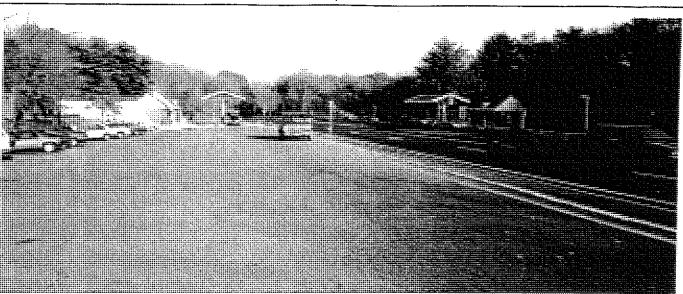
## STATION 075+350 NEW CANAAN SERVICE AREA WESTBOUND, LOOKING EAST

Exit lane and parking area configuration at service areas:

- Large underutilized expanse of pavement
- Inefficient parking/circulation layout
- Inadequate buffer between pump area/service lane and adjacent Parkway travel lane
- Short re-entry lanes back onto Parkway
- Frequent exposed views to rear lot parking and adjacent Parkway maintenance buildings and land use

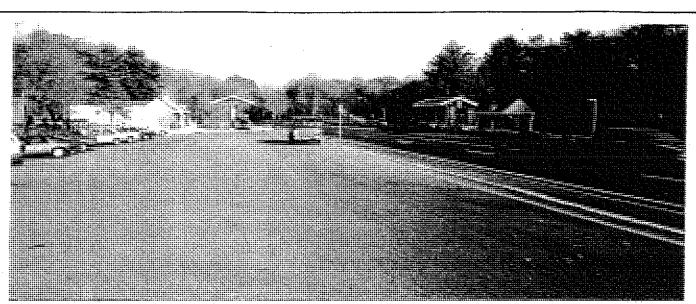
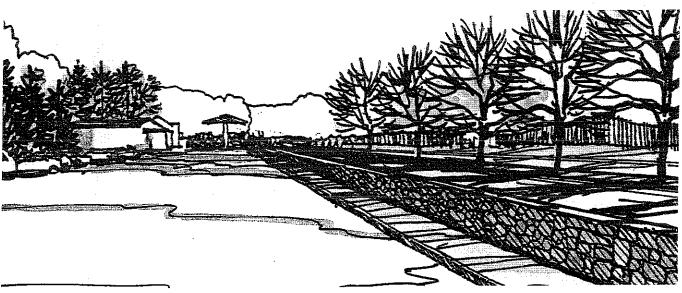
EXISTING

Add "faux" stone wall guiderail/barrier to edge of exit lane/parking lot.

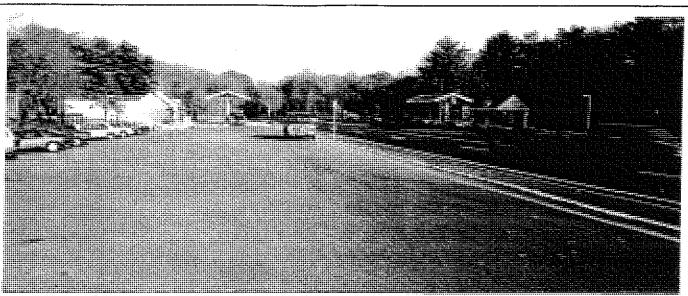
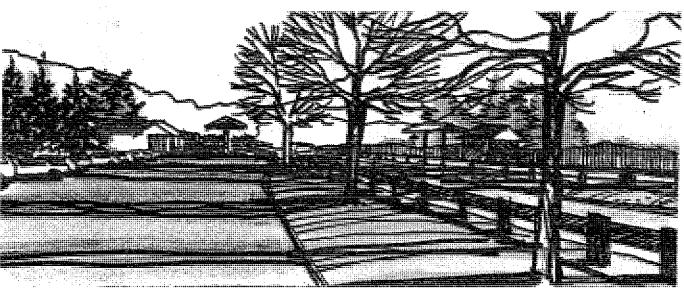
EXISTING

Push parking edge back 20 feet; add landscape island past pump area along travel lane; extend exit lane; add guiderail system.

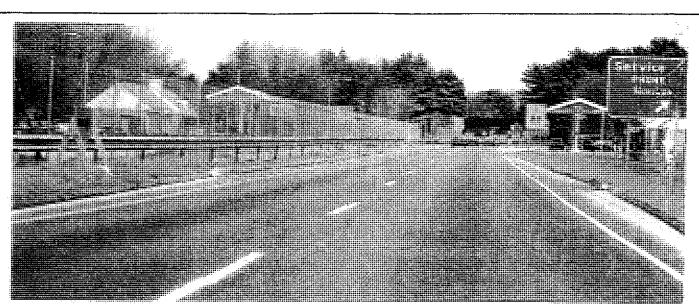
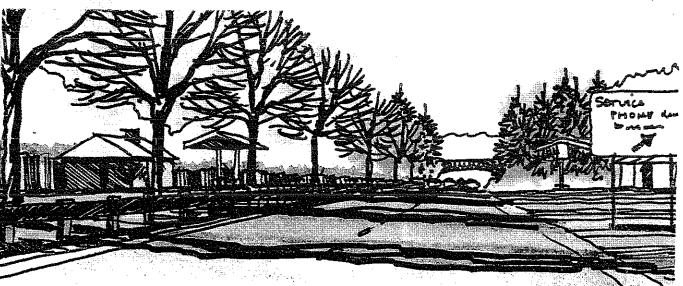
EXISTING

Remove chain link fence; plant median trees and add median guiderail; implement management change or install underground "pneumatic tube" system between stations.

Merritt Parkway Landscape Master Plan	CONCEPT	4.3.3
State of Connecticut Department of Transportation	MANUAL	2
Service Areas Median Treatment	Milone & MacBroom, Inc. Johnson, Johnson & Roy, Inc Johnson Land Design Filzgerald & Halliday, Inc.	2.

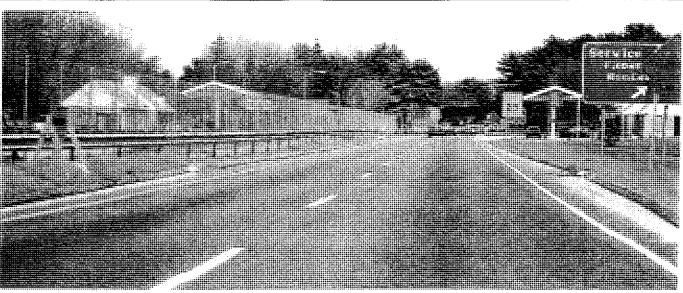
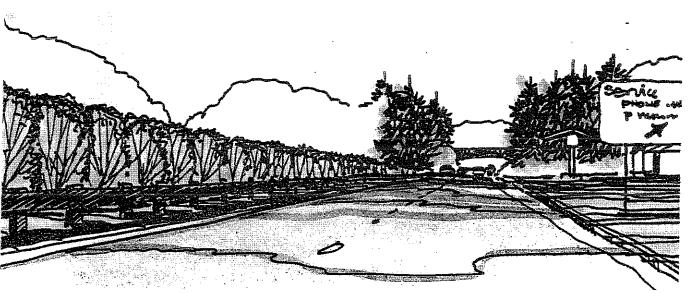
EXISTING

Pull guiderail to edge of median; add shrub hedge behind guiderail to screen fence (chain link fence remains).

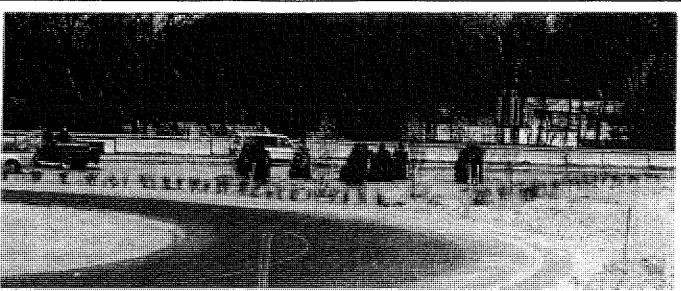
#### EXIT 47 OFF RAMP, LOOKING NORTH ACROSS MERRITT PARKWAY

- Vegetation should be brought to within 30 feet of the roadway and a forest edge re-established.
- At bridge abutments, the landscape treatment should be brought down to the roadway edges.
- Slopes at bridge abutments should be regraded slightly to extend out and blend with the existing topography.
- Median trees should be added.
- Conifers should be planted to accentuate rock outcrops and to define leading curves.

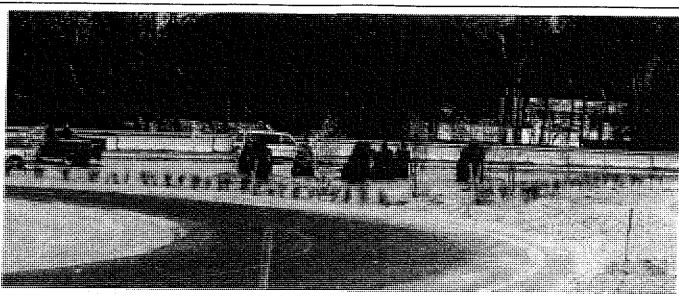
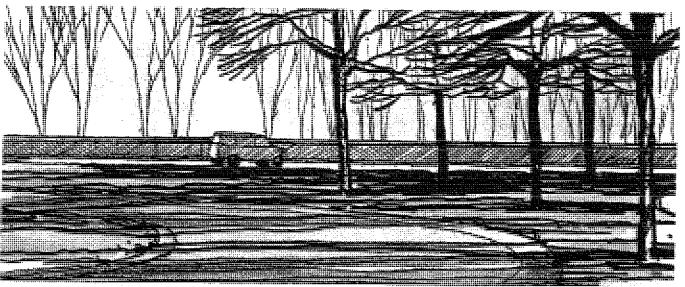
#### EXISTING

Landscape treatment at interchange islands:

Landscape islands should remain as lawn or lawn and trees with tree mass held back from travel lanes; plant palette to match surrounding landscape.

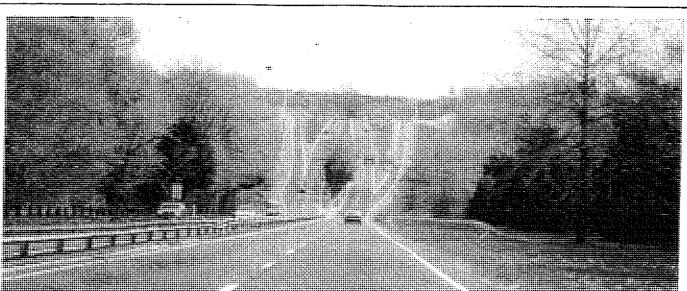
#### STATION 087+800 LOOKING EAST TOWARDS ROUTE 7 INTERCHANGE

Open, unlandscaped approaches to major new interchanges:

- Significant change in character from historic Parkway condition to new interchanges
- Opportunity to better enclose and enframe approach views
- Long downhill view
- Narrow median (no opportunity for median trees)

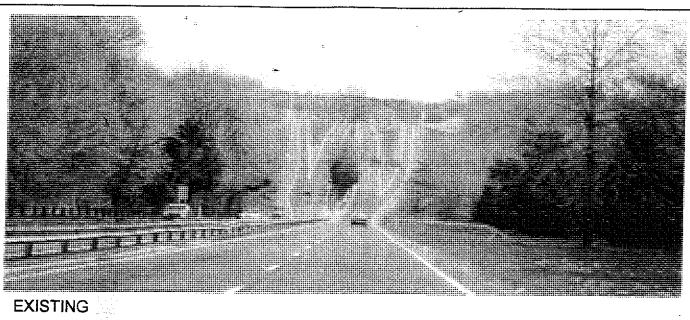
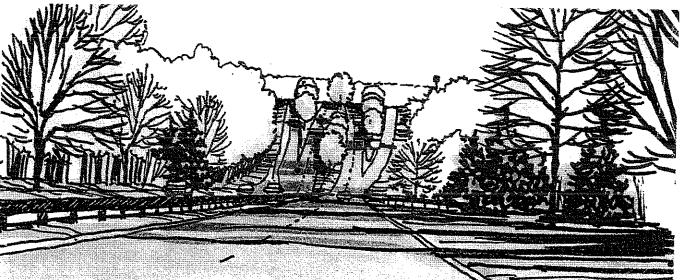
Keep landscape edge the same (in foreground) and add median trees and trees along on/off ramps (in distance).

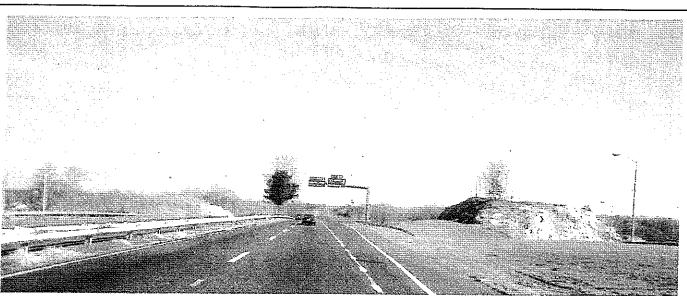
#### STATION 090+600 LOOKING EAST THROUGH ROUTE 7 INTERCHANGE

- No enclosure or spatial variety
- Open, barren landscape not consistent with Parkway history or character
- Pavement wider than other sections of Parkway
- Signage, guiderails, and lighting not consistent with Parkway
- Unnatural rock cut not consistent with historic treatment of similar conditions

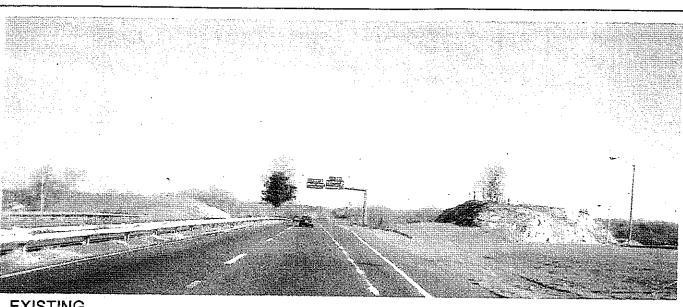
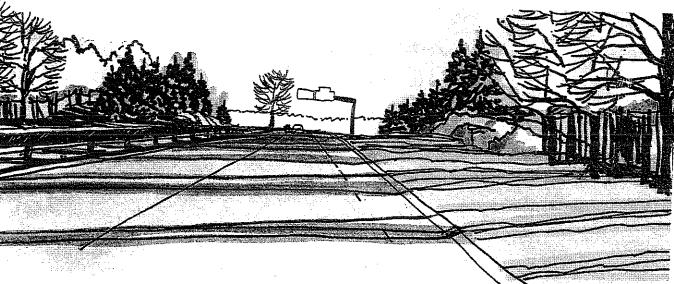
EXISTING

Re-introduce conifer stands along rock cut; re-establish deciduous woods, holding back wooded edge to 30 feet from roadway; bring lawn closer to road edge.

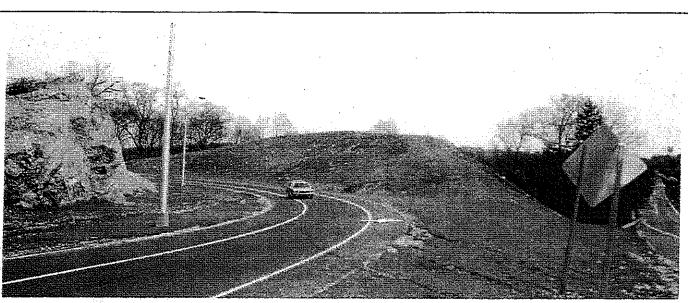
#### STATION 092+000 LOOKING NORTHEAST AT ROUTE 7 SOUTHBOUND ON RAMP

Open, unlandscaped entrance and exit ramps at major new interchanges:

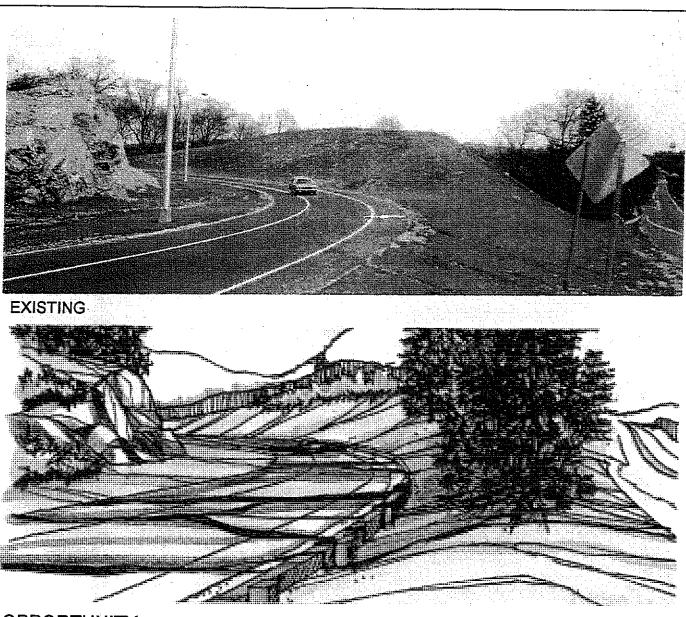
Major landscaping opportunity: re-establish deciduous woods in area, with stands of conifers on rock cut and on leading curve of on-ramp; add guiderail at outside edge.

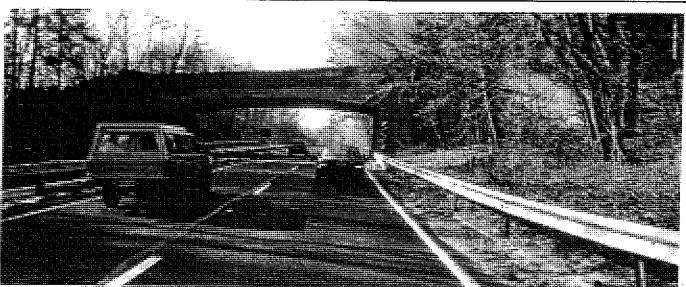
STATION 052+670 LOOKING SOUTH TO WIRE MILL BRIDGE

Invasive growth at bridge abutments:

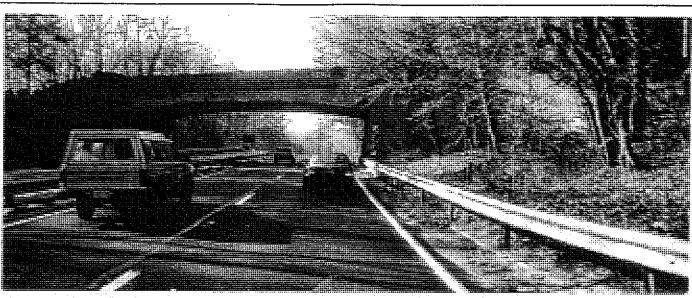
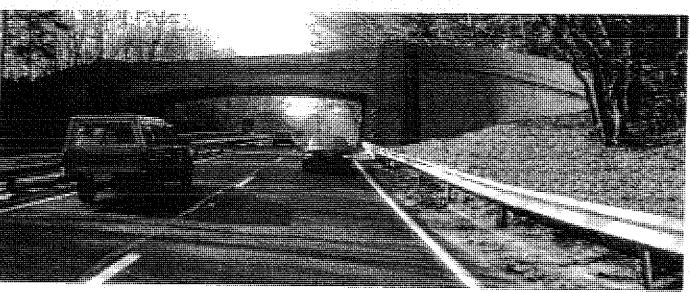
**EXISTING**

**OPPORTUNITY:** Clear invasive growth at bridge abutments.

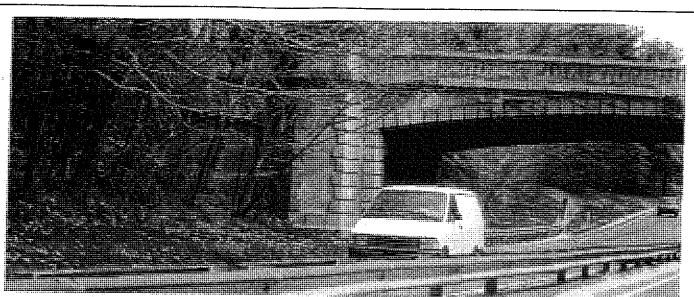
#### STATION 065+790 LOOKING NORTH TO PONUS ROAD BRIDGE ABUTMENT

Invasive growth at bridge abutments:

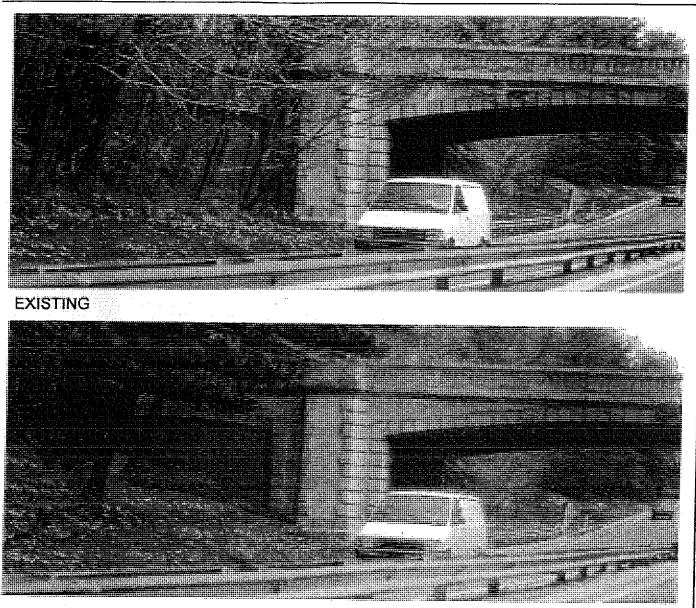
Clear invasive growth at abutment and re-establish original bridge plantings.

Slope stabilization in areas of steep slope; quality of original plant material once invasive growth removed; ongoing maintenance to keep invasive species under control.

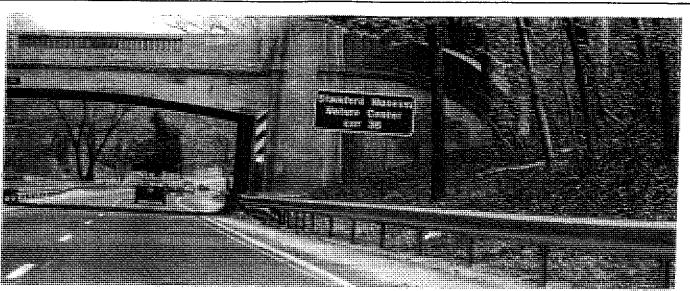
#### STATION 052+080 LOOKING NORTH TO WIRE MILL ROAD BRIDGE ABUTMENT

Visually obtrusive sign at bridge abutment:

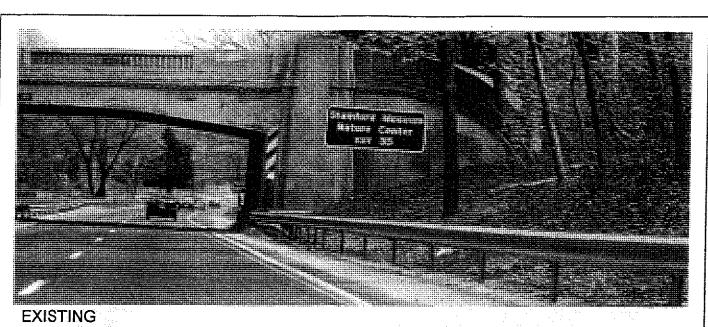
Remove visually obtrusive sign and clear invasive growth at abutments.

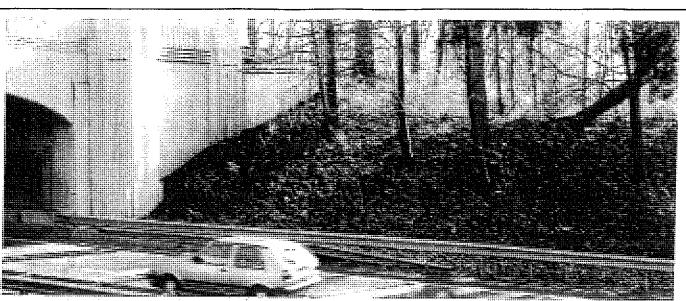
STATION 71+850 LOOKING NORTH AT BRIDGE ABUTMENT, LAPHAM AVENUE BRIDGE (SOUTHBOUND)

Inconsistent barrier/guiderail design at existing bridge abutments:
