Routes 7/15 Interchange Norwalk, Connecticut State Project No. 102-358

Environmental Assessment, Draft Section 4(F) Evaluation and Environmental Impact Evaluation

# PUBLIC REPORT PHASE I AND II CULTURAL RESOURCE SURVEYS ROUTE 7/ROUTE 15 INTERCHANGE PROJECT STATE PROJECT NO. 102-358 NORWALK, CONNECTICUT

December 13, 2018 Updated August 24, 2020

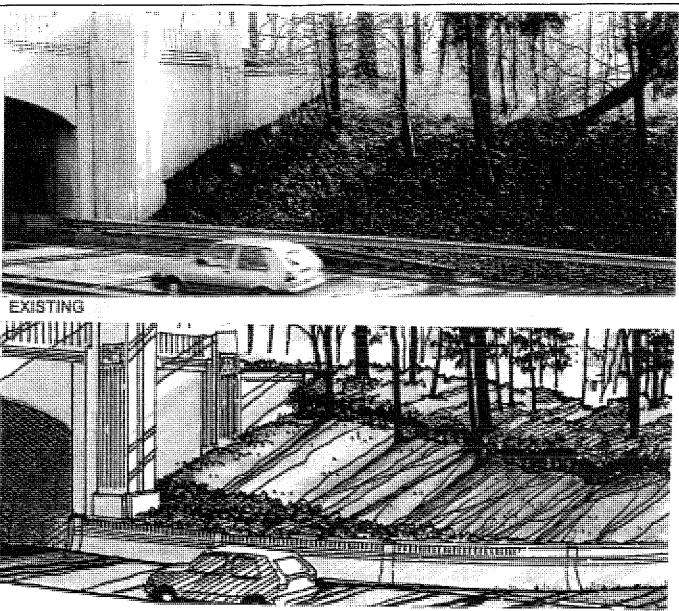
Unified bridge abutment treatment with customized permanent barrier at edge of roadway; low ground cover on slope; taller ornamental shrub mass at top of slope.

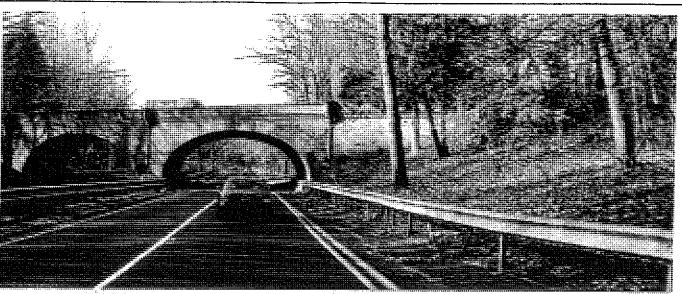
STATION 107+150 LOOKING SOUTHBOUND TO NEWTOWN TURNPIKE BRIDGE

End treatment for proposed barrier at bridge abutment:

- Must minimize length of proposed barrier system while meeting all traffic safety standards
- Opportunity to tie barrier back into slope where conditions permit
- Opportunity to transition to steel-backed wood beam guiderail dependent on site conditions

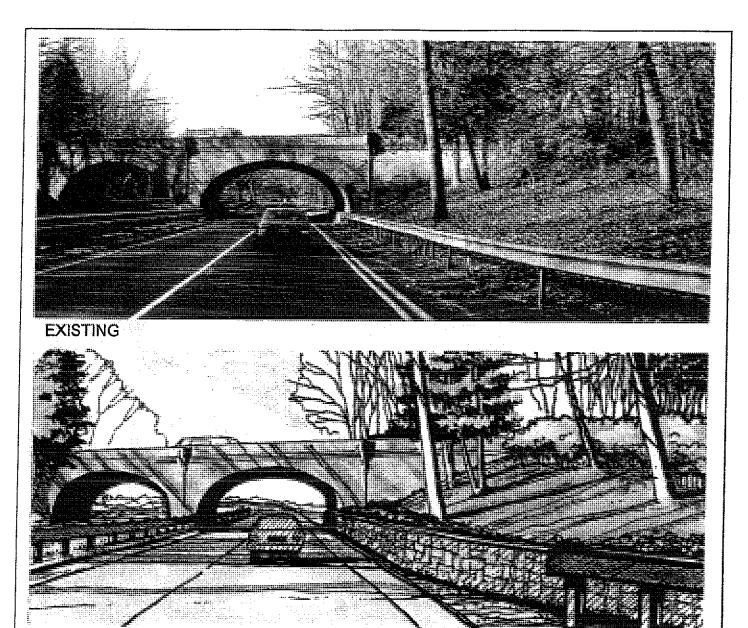
Tie back bridge abutment barrier to steel-backed wood beam guiderail (guiderail to overlap and bolt to barrier, barrier to taper into ground).

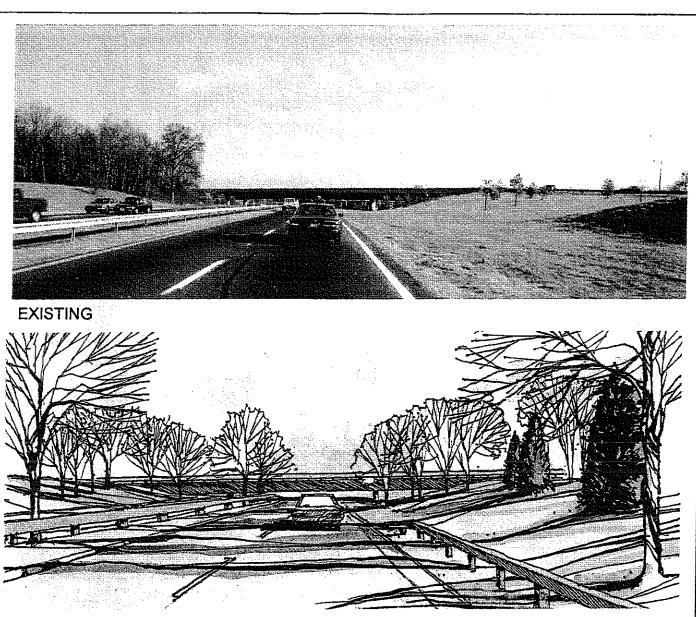
Landscape to enclose bridge approach; opportunity for "park-like" pockets and median trees.

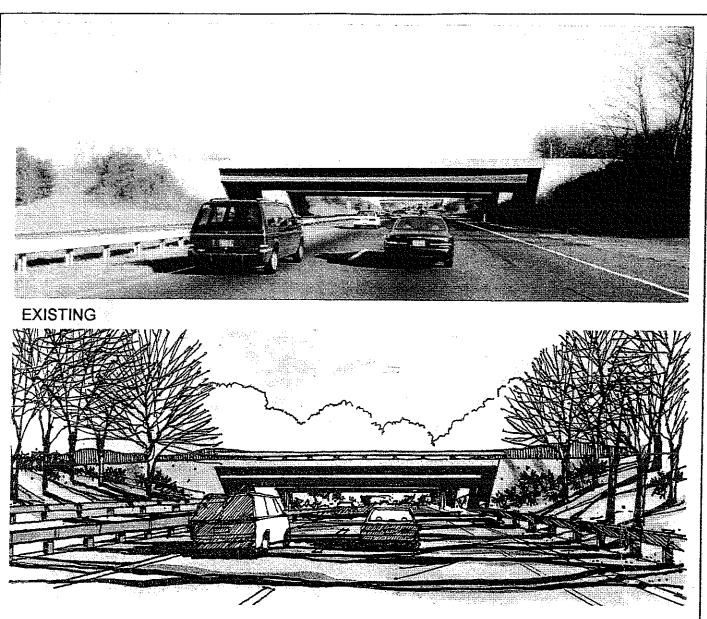
Add modest but decorative railing along bridge parapet; regrade and extend slope out from abutments; bring trees/landscape edge closer to roadway; add consistent guiderails.

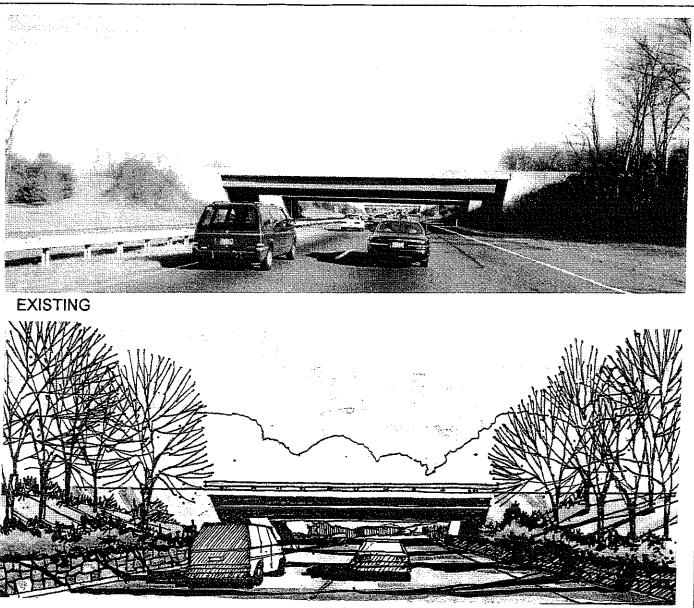
Regrade and extend slope out from abutments; bring trees/landscape closer to pavement edge; permanent barrier with planted shrubs as guiderail system.

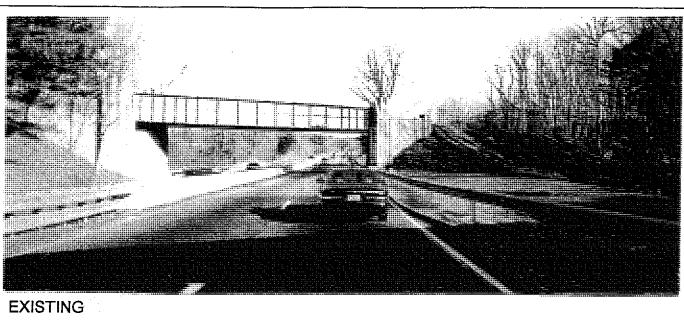
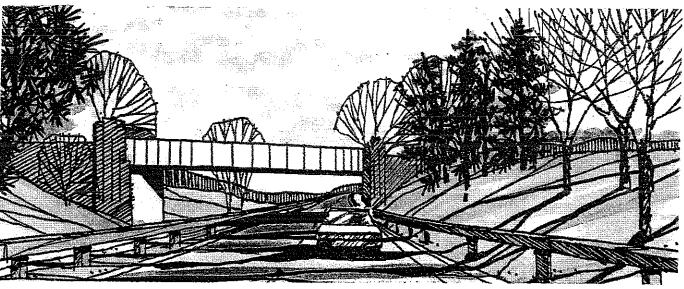
#### STATION 171+000 NORTHBOUND LOOKING AT OLD RAILROAD BRIDGE, NEAR EXIT 49

Regrade and extend slope at abutment; bring landscape edge closer to road; utilize consistent guiderail system.

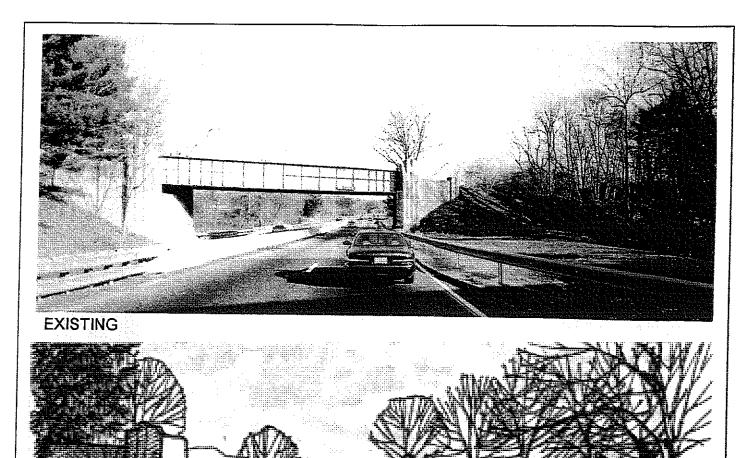
Remove unused bridge span; regrade and landscape abutments; utilize consistent guiderail/barrier.

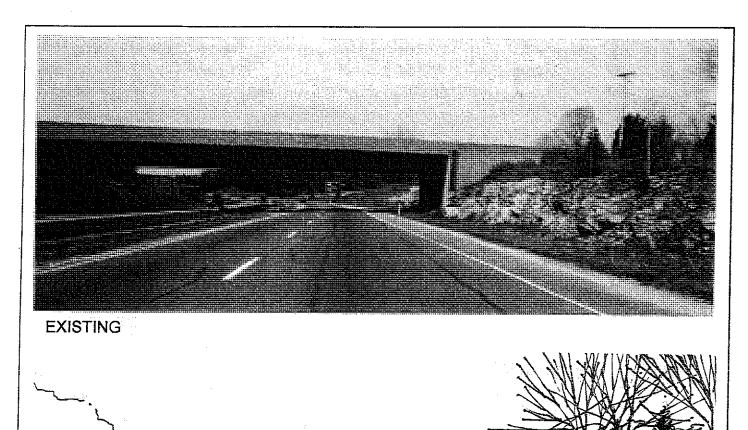
#### STATION 178+550 LOOKING SOUTHBOUND AT NICHOLS AVENUE BRIDGE, EXIT 52, ROUTE 8

Enhance bridge architecture with additional detailing and addition of center bridge pier; landscape edge brought closer to roadway and rock face.

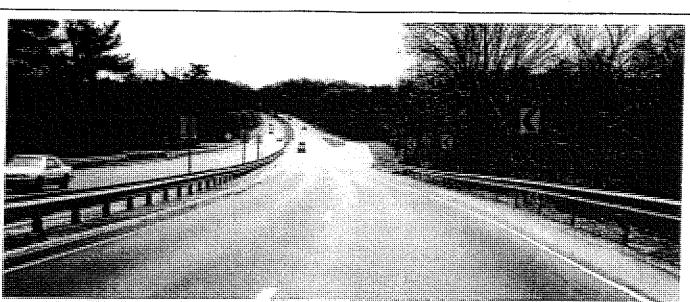
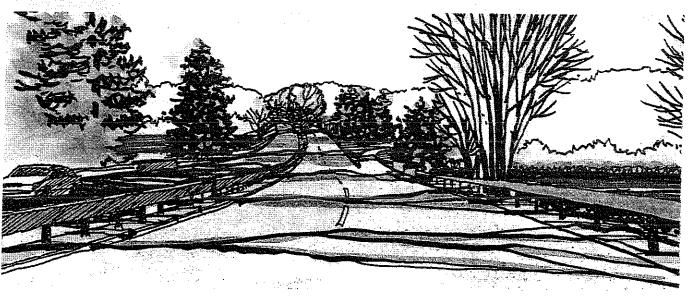
#### STATION 009+000 OLD TOLLGATE PLAZA AREA, LOOKING SOUTHBOUND

Redesign access lane to maintenance facility and add lawn area at edge. Clear invasive growth at roadway edge to open up views to ponds. Add median trees (in distance).

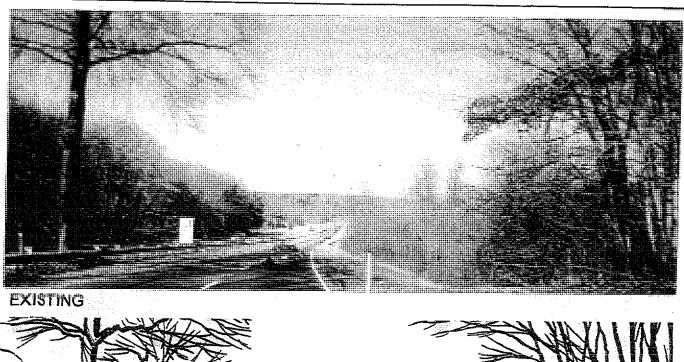
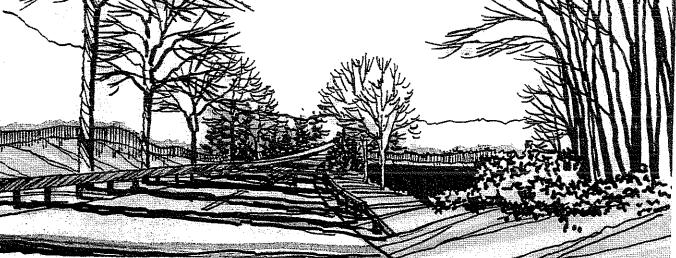
#### STATION 007+100 OLD TOLLGATE PLAZA, LOOKING EAST

Clear invasive at roadway edge. Add median trees and a few specimen trees at edge of pond.

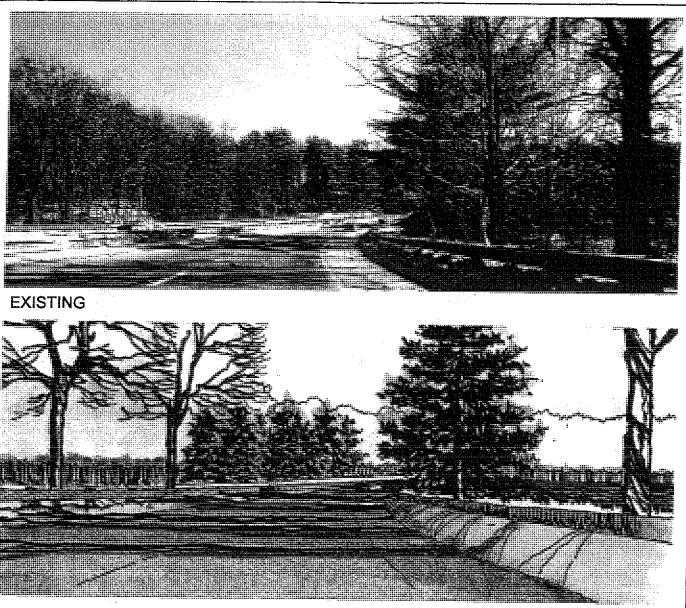
#### STATION 028+000 LOOKING NORTHBOUND AT PUTNAM LAKE

Clear invasive growth at lake edge. Prune lower branches of existing pines. Add evergreens on opposite curve of roadway. Add deciduous median trees.

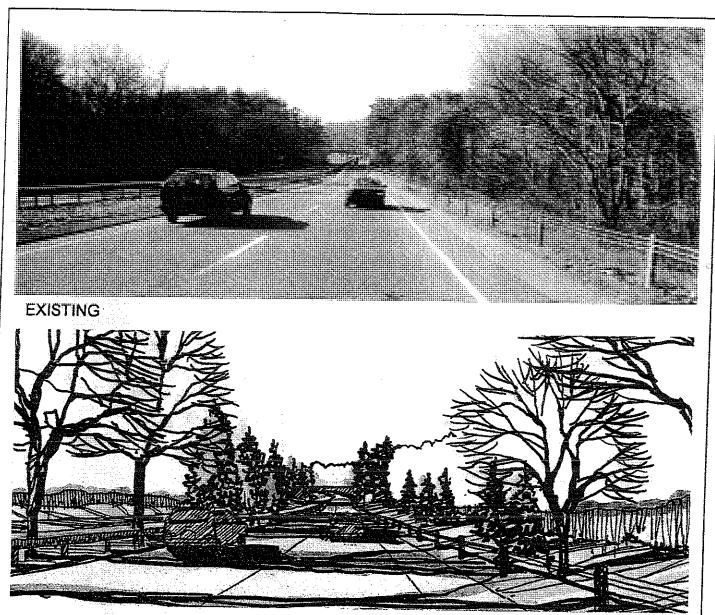
#### STATION 039+950 LOOKING SOUTH TOWARDS STANWICH ROAD BRIDGE

Clear invasive species at edge. Pull back woods at edge. Re-establish lawn; add specimen trees at edge; add median trees.

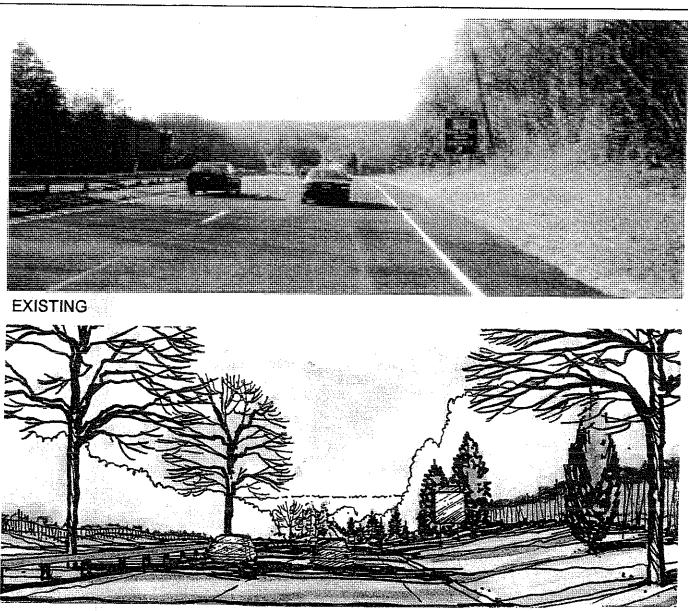
#### STATION 051+700 SOUTHBOUND TOWARDS EXIT 34

Enhance "park-like" setting by clearing invasive vegetation, pulling back and defining wooded edge; add individual and small groups of trees and occasional median trees.

Plant material must be in context with surrounding site conditions; requires guiderail placed at edge of median and possible additional guiderail sections at outer edge.

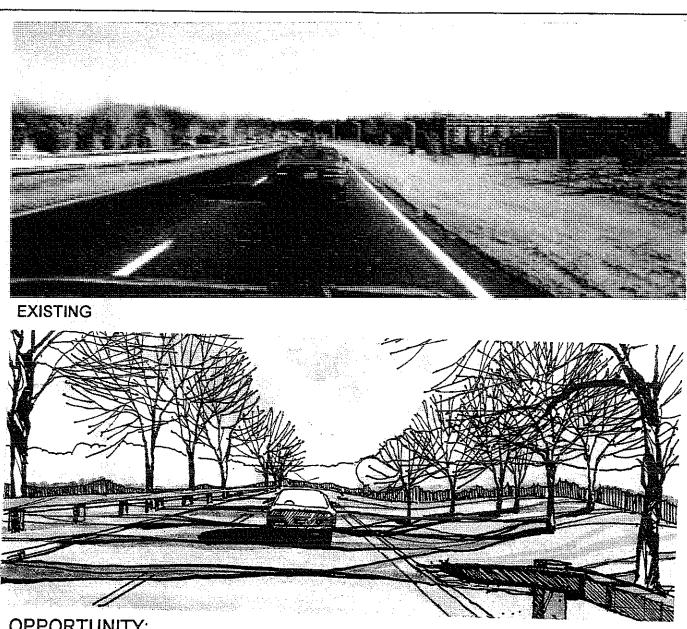
STATION 180+800 LOOKING NORTHBOUND AT EXIT 52, ROUTE 8

Enclose areas of recent alterations through regrading and reforestation. Add median trees for enciosure.

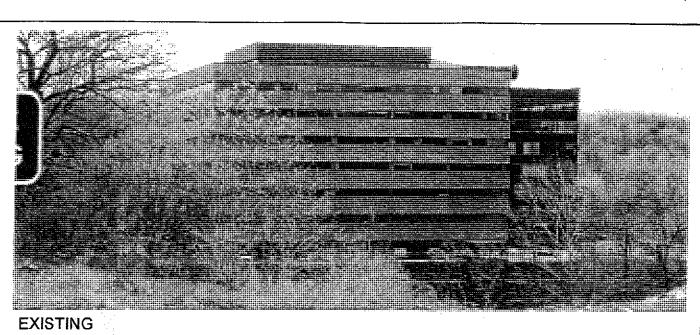
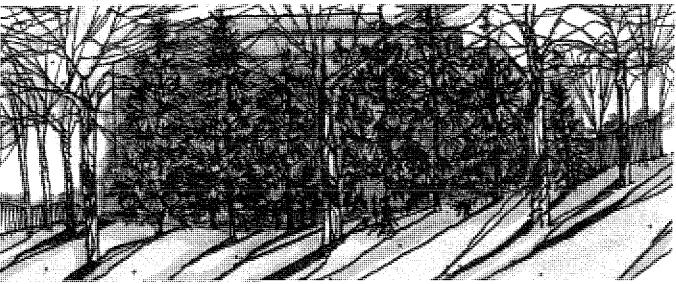
#### OFF-SITE VIEWS ADJACENT TO ROUTE 7 (NORTHBOUND)

Raise grade and add deciduous/coniferous vegetation along face of slope.

Length of time for maturation; may need additional guiderail at edge if planting area is too narrow.

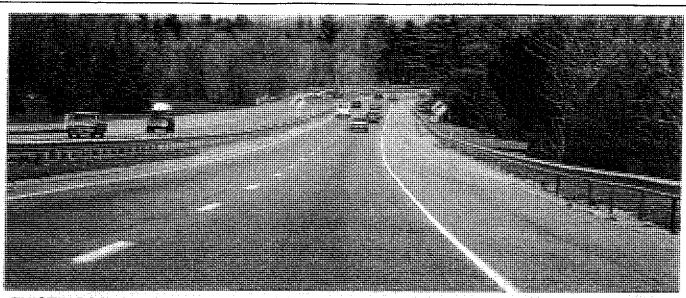
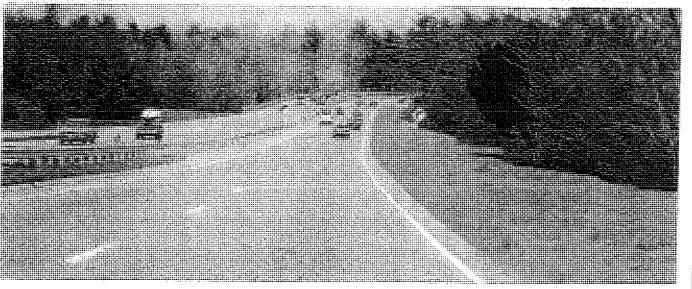
STATION 008+750 LOOKING EAST PAST FORMER TOLL PLAZA

Replace widened pavement with lawn, remove edge guiderail.

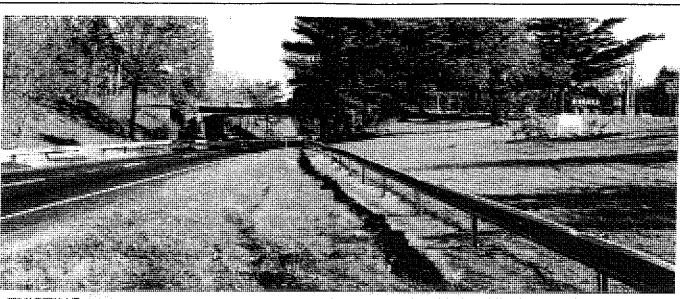
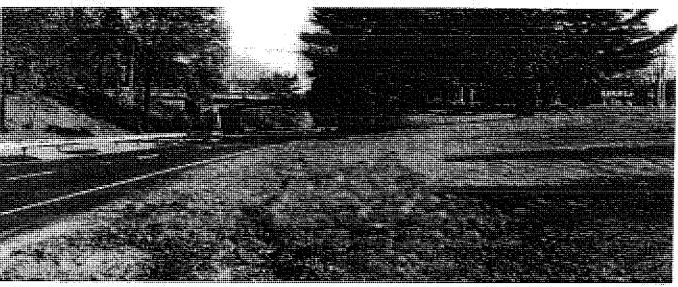
EXISTING

Removal of miscellaneous roadside elements where not needed; re-establish lawn areas.

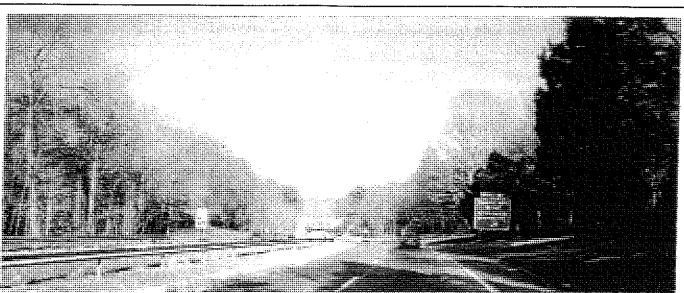
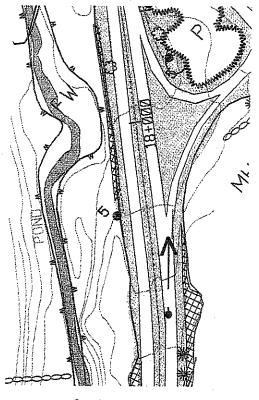
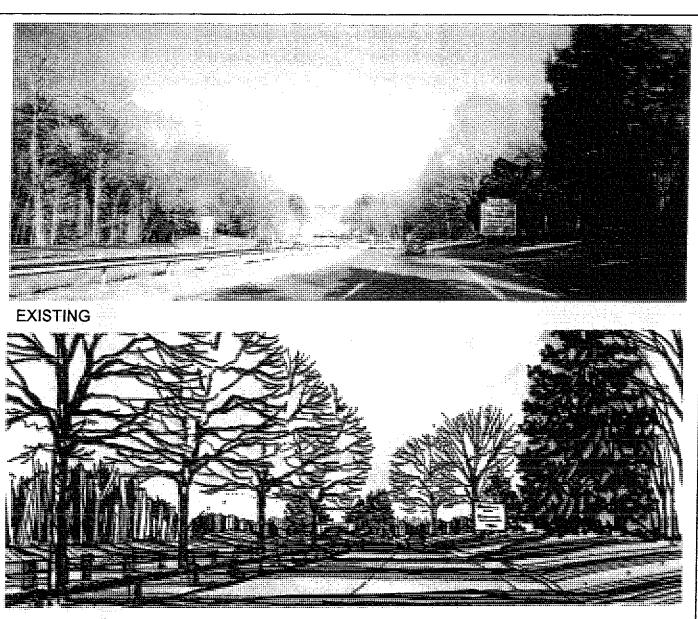
#### STATION 017+800 ROUND HILL ROAD LOOKING EAST

- Median trees have been removed and never replaced
- Long open sections of median lack variety of spatial sequence
- Use of trees in median consistent with original planting scheme for Parkway
- Plant type must be compatible with nearby plant community
- New median trees require new guiderail at edge of pavement

### **Median Treatments** Vegetation - Tree Addition/Framing Views

Add trees to median where there is adequate width.

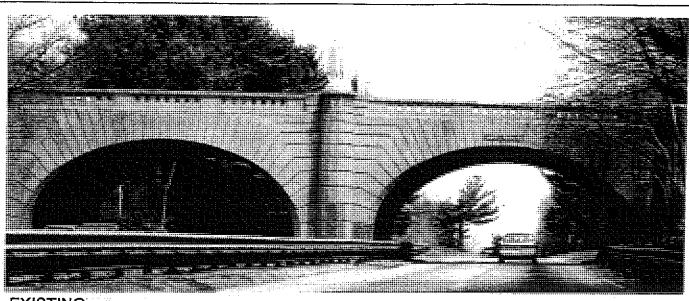
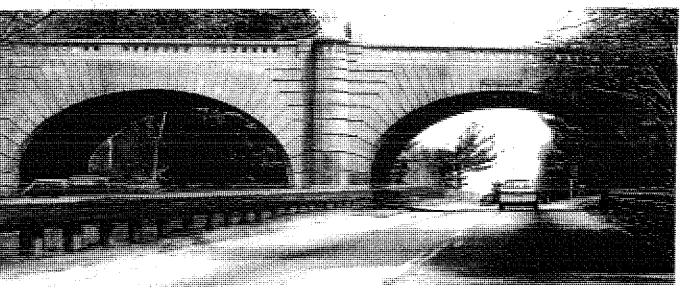
EXISTING

Steel-backed wood beam with wood posts.

Design and bulk of guiderail needs to incorporate all necessary safety criteria. Can only be utilized where median width is eight feet to provide for deflection. High cost to install and maintain.

Merritt Parkway Landscape Master Plan	CONCEPT	4.7.2
State of Connecticut Department of Transportation	MANUAL	<b>2</b>
Median Treatments Barriers and Guiderails	Milone & MacBroom, Inc. Johnson, Johnson & Roy, Inc Johnson Land Design Fitzgerald & Halliday, Inc.	·-

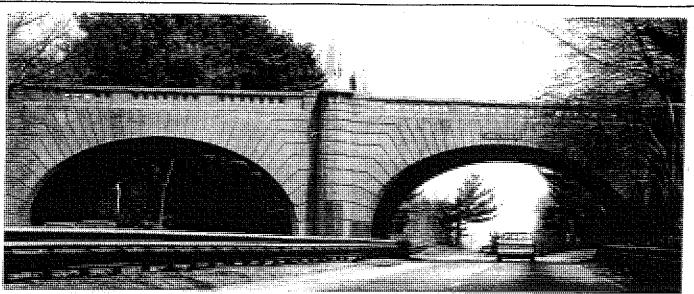
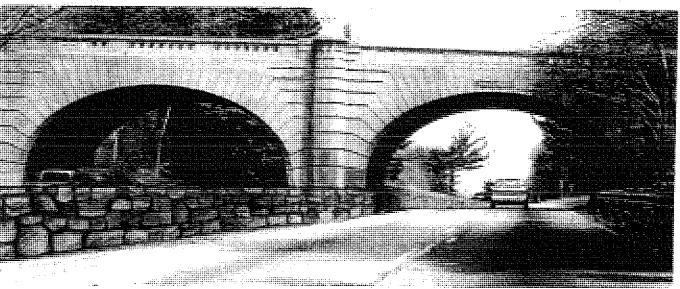
EXISTING

"Faux" Connecticut stone wall barrier having uniform design throughout the Parkway utilized at all bridge underpasses.

"Faux" Connecticut stone wall not as visually compatible with all bridge designs. Potentially higher cost of installation.

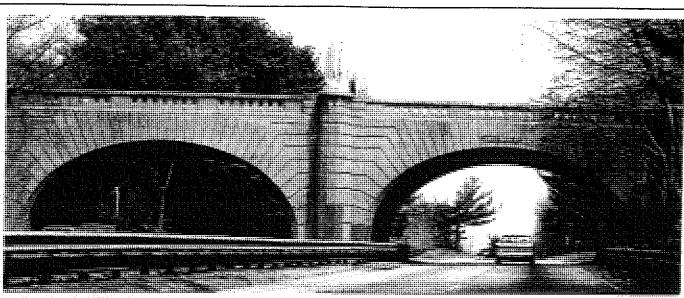
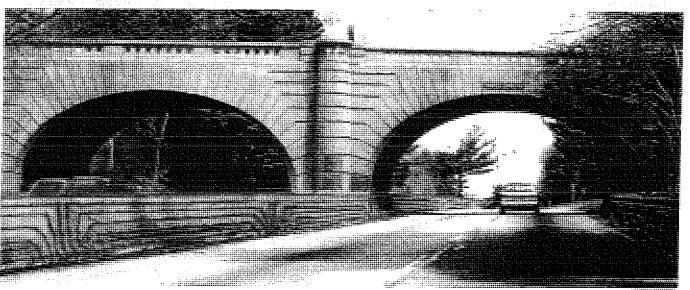
Existing

Designed concrete barrier having standard height unique to each bridge (both northbound and southbound approaches).

Potential high cost design solution. Extension of the design detailing could dilute the overall visual impact of the bridge's architecture.

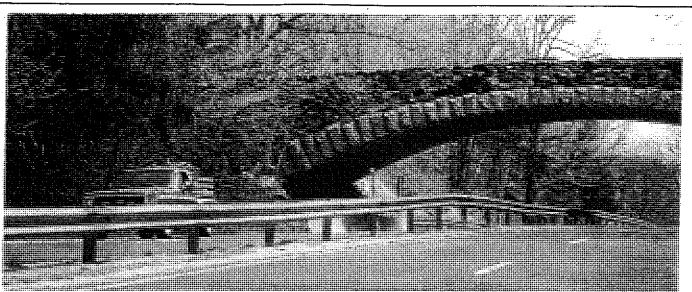
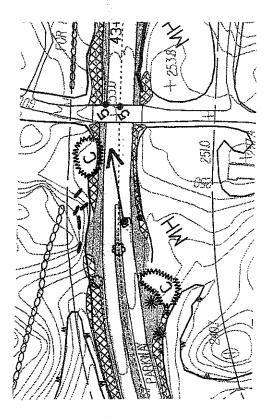
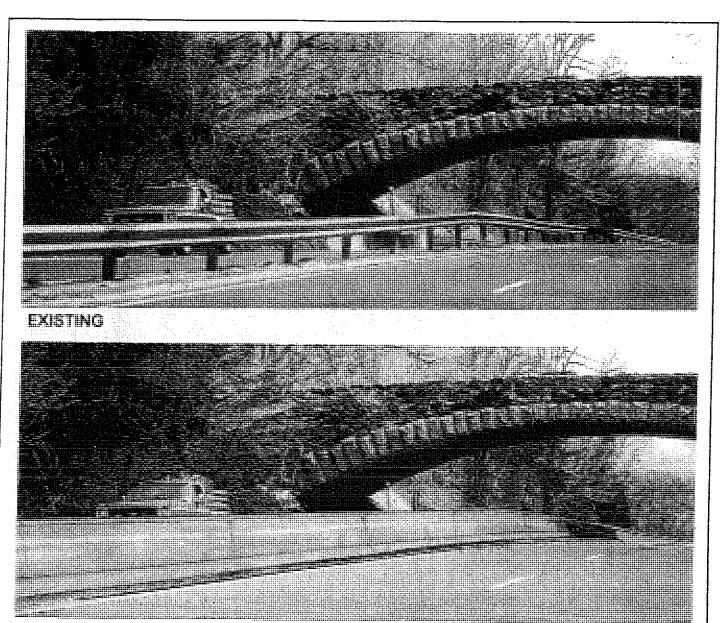
#### STATION 042+500 GUINEA ROAD BRIDGE, LOOKING EAST

#### OPPORTUNITY: Precast concrete barrier (plain/standard).

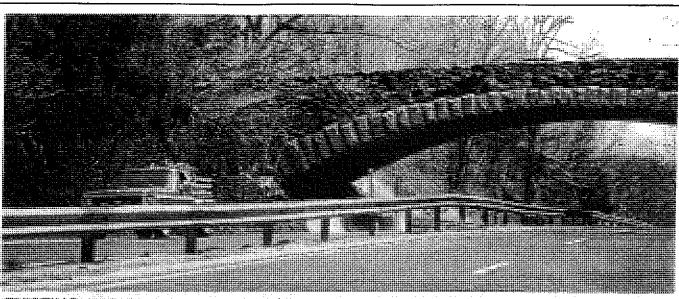
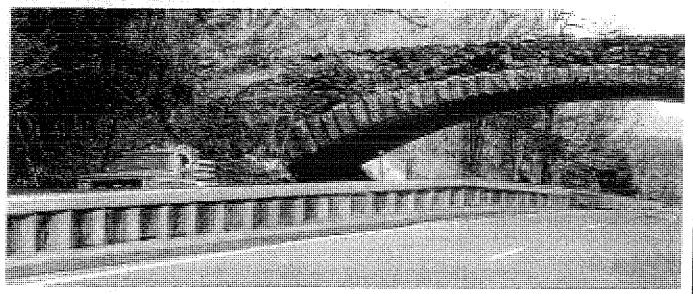
EXISTING

A concrete barrier having a uniform design throughout the Parkway utilized at all bridge underpasses.

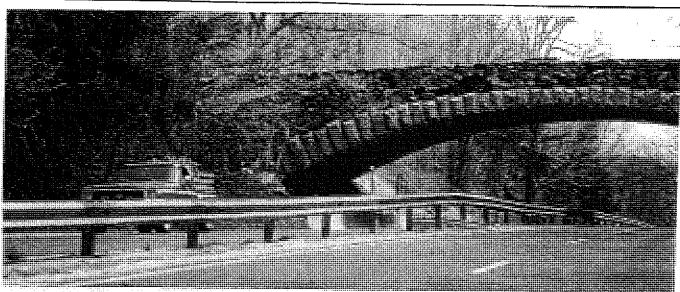
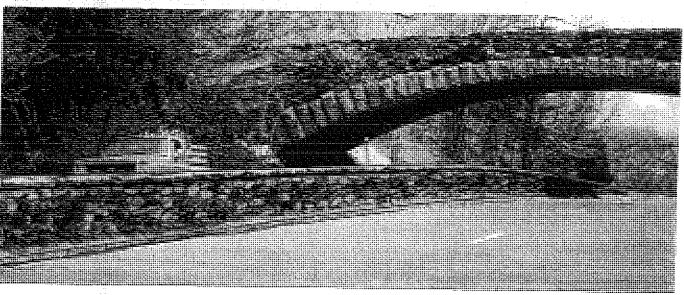
EXISTING

"Faux" Connecticut stone wall underpasses - or a specific design only for Guinea Road and other stone faced bridges.

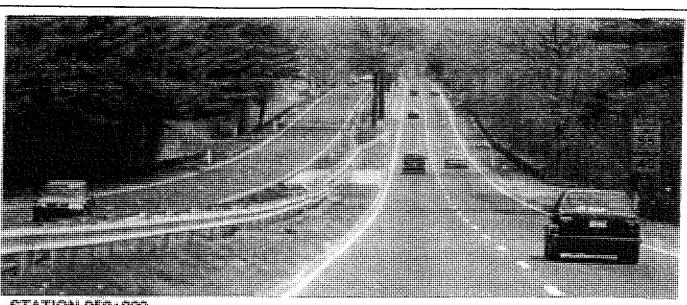
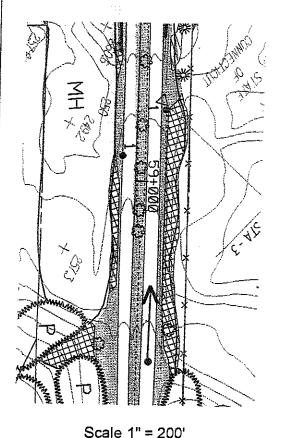
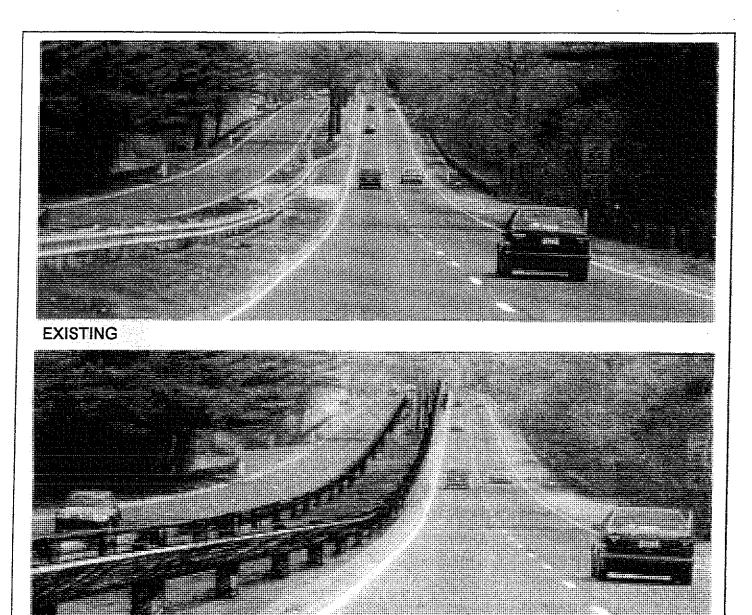
STATION 058+800 WEST OF NEWFIELD AVENUE

Irregular or inconsistent guiderail layout in wide median (median boats):

#### OPPORTUNITY: Steel-backed wood beam guiderail pulled to edge.

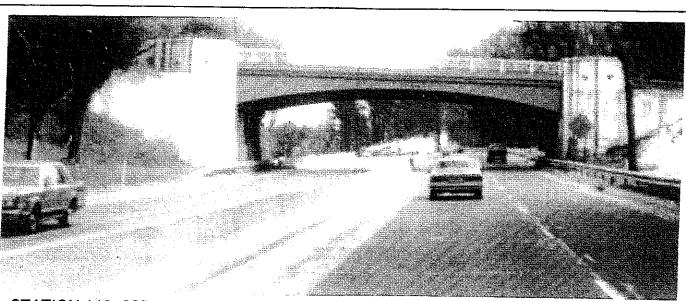
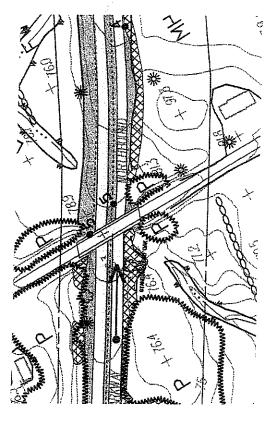
#### STATION 112+225 LOOKING NORTH AT CLINTON AVENUE BRIDGE

Median guiderail treatment (narrow median with existing concrete barrier):

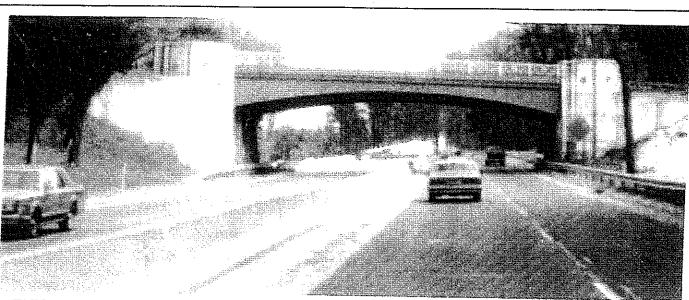
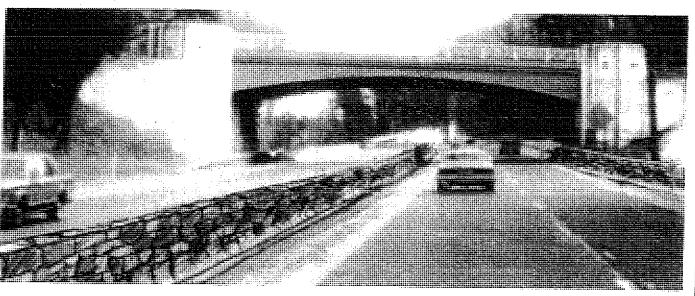
**EXISTING**

Replace with "faux" Connecticut stone wall barrier (precast embossed concrete).

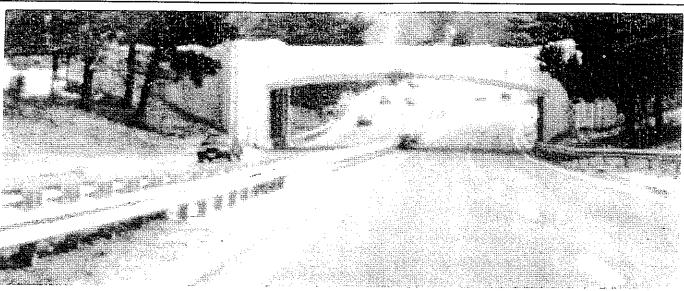
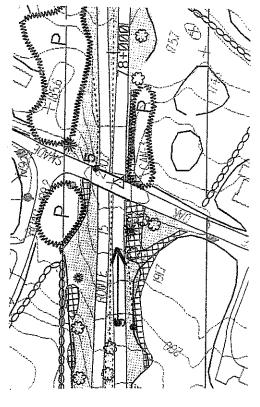
#### STATION 077+370 LOOKING NORTH TO WHITE OAK SHADE BRIDGE

Median guiderail treatment at transition points from wide to narrow medians:

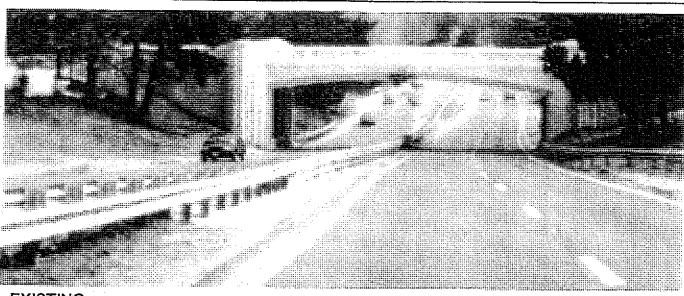
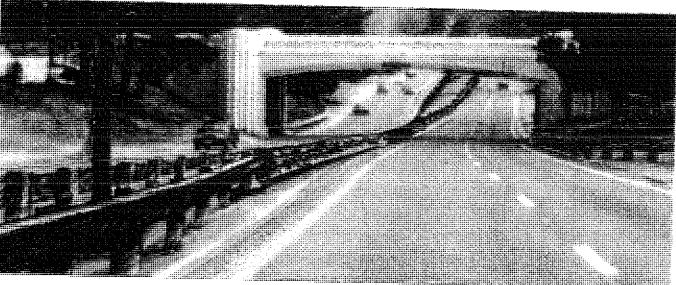
EXISTING

Guiderail transitioned to "faux" Connecticut stone wall barrier beneath bridge.

"Faux" Connecticut stone wall barrier more "park-like" in general context, but may be less compatible with certain bridge designs; barrier terminal end must meet safety criteria.

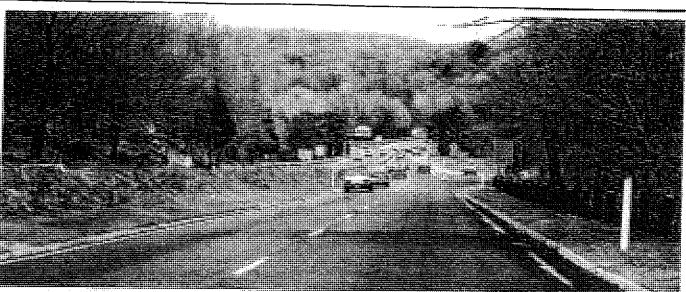
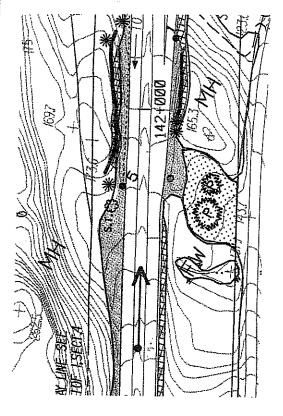
# STATION 141+470 LOOKING NORTH TO EXIT 44

Bermed median (unique condition along Parkway):

- Berm treatment not consistent with any other section of the Parkway median
- Median condition and slope of berm create maintenance problems
- Irregular surface of grass and mulch visually distracting
- Height intended to cut glare of on-coming traffic headlights

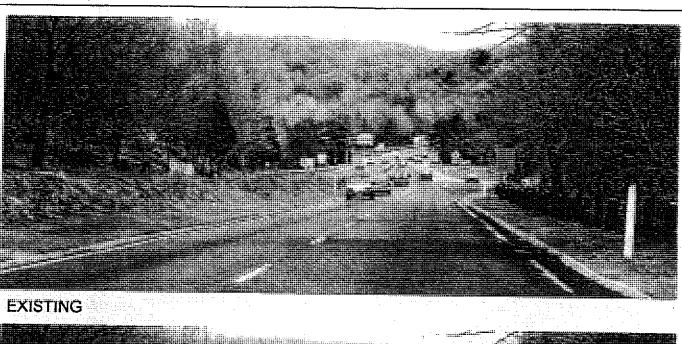
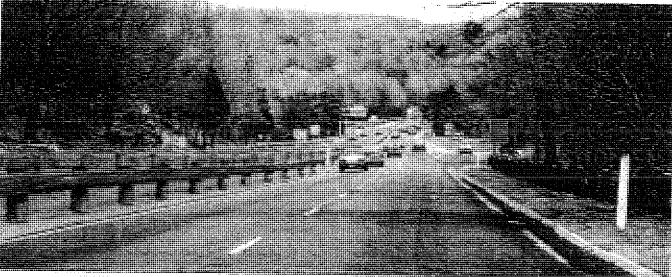
Regrade and replace mound with uniform guiderail.

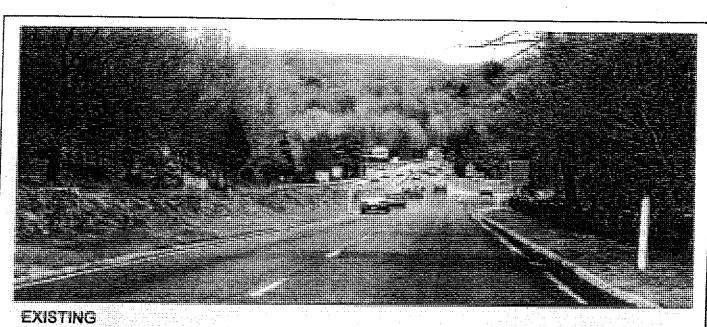
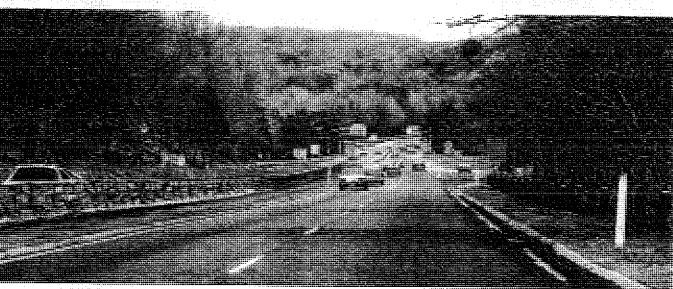
Replace mound with "faux" Connecticut stone wall.

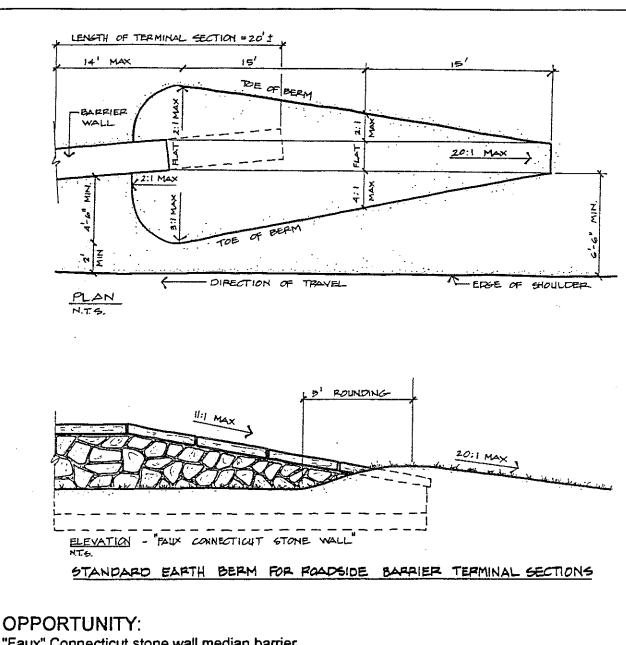
"Faux" Connecticut stone wall median barrier.

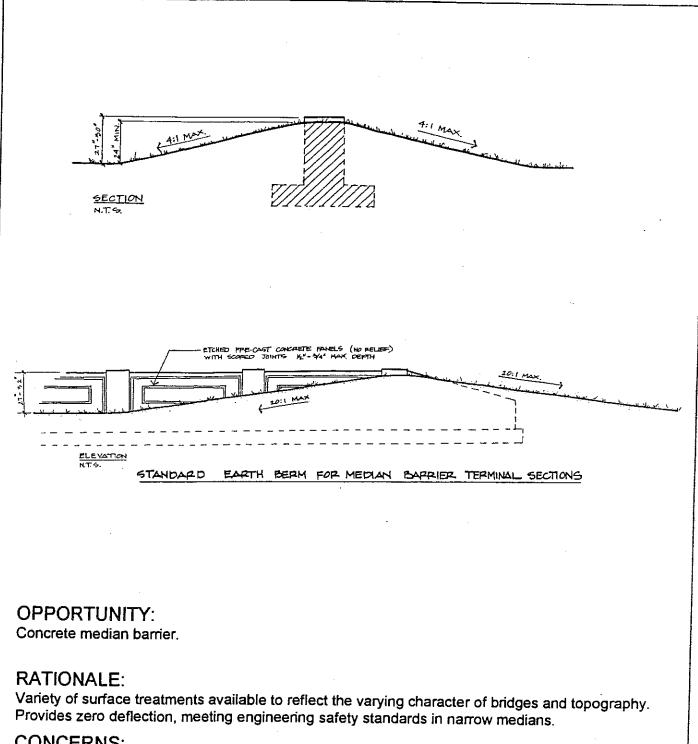
# **Median Treatments Barrier and Guiderail Details**

# CONCERNS:

Provide earth berm at terminus for safe transition in direction of travel meeting Federal Highway Administration Standards. Barrier must be extended to location in median with sufficient width to accommodate earth berm.
